**SAFETY
ALERT**

Slide Pulsators

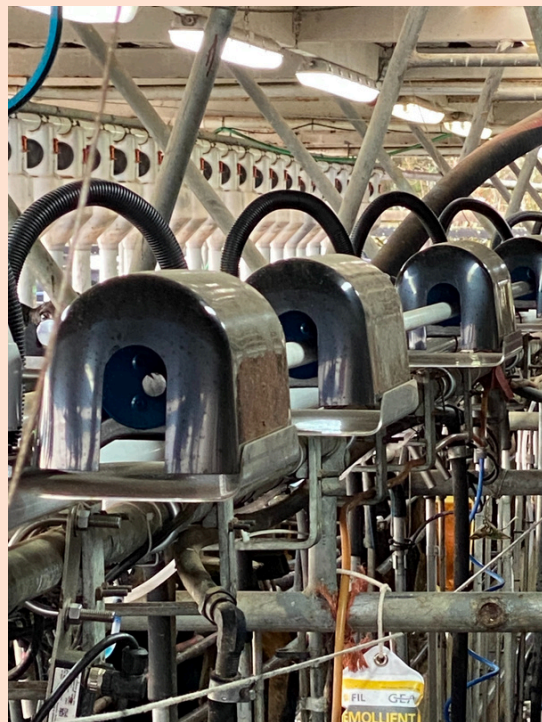
This Safety Alert has been issued to urge caution when working around mechanical pulsators in milking sheds, following a fatal incident where a farmer's clothing became entangled in the rotating bar of a slide pulsator. WorkSafe is still investigating the fatality. There is no indication the farmer intentionally reached into any part of the machinery.

The industry is advising caution around slide pulsators. Slide pulsators in milking sheds have a rotating drive shaft which may be slow, but is incredibly powerful due to the reduction gearbox. The risk of entanglement in machinery is real. Take the necessary steps to manage that risk.

- Take a look around your farm and identify where you or your team can be exposed to moving machinery. Remind your team of the danger any rotating shaft on farm can expose.
- Any rotating machinery should have protective guards on it, even if it's routinely out of reach. Consider covers and sleeves over moving parts (as pictured).
- Speak to the manufacturer if you are unsure what guarding to use.
- Review what is deemed as safe clothing with your team - clothing that won't get caught in machinery.
- Ensure kill switches or e-stops are located in an easily accessed location and are well signposted. Do you need a pull cord with electric kill switch?
- Don't wait, take steps now.
