Examples of Belzona Applications at Healthcare Facilities

ASSET INTEGRITY AND HIGH PERFORMANCE IN HEALTHCARE

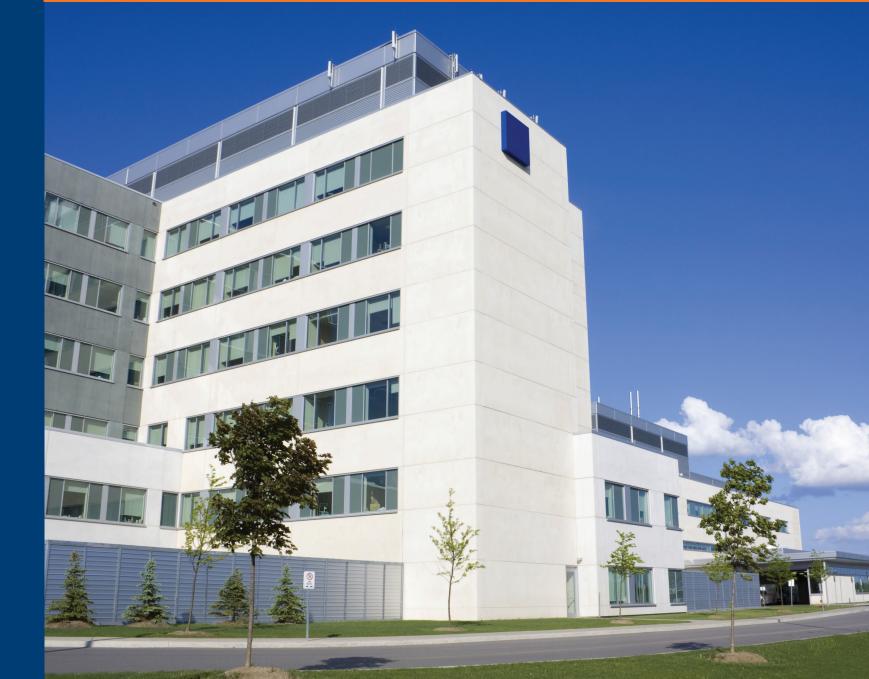
This diagram of a typical hospital facility is designed based upon data retrieved from various sources. It is to be used as general guidance only. It describes the most common repair and maintenance problems found in healthcare facilities together with Belzona solutions which could potentially help mitigate such problems. It does not aim to supersede any drafted process flow charts in use at these facilities. It is strongly recommended that each user of this guide contact the local Belzona representative to discuss the specific needs and operation conditions of their healthcare facility.

ROOFS

TYPICAL PROBLEMS: Weathering and/or physical damage to roofs and roof parts: joints, seams, edges, glazing sections, gutters, flashings, skylights, parapet walls and copings, pipes and pipe supports. The damage is typically caused by weather and freeze-thaw cycles, failure of roof materials, substrate movement or impact.

POTENTIAL SOLUTIONS: Belzona 3000 series fluid-grade membranes for weatherproofing, waterproofing, repair and protection of all roof types and roof parts.

FLOORS

TYPICAL PROBLEMS: Damage of concrete floors and structures due to weather fluctuations, chemical attack or physical impact, slippery transit areas, expansion joints failure.

POTENTIAL SOLUTIONS: Belzona 1000, 2000, 4000, and 5000 series paste- and fluid-grade materials for floor slip resistance, safety markings, concrete restoration and levelling, expansion joints repairs, replacement and installment of new "smooth ride" joints, new floor installation in kitchens, dining halls, patient waiting rooms, operation rooms, entryways, parking lots, laundry facilities, mechanical rooms, loading docks, waste and water management facilities.

HVAC SYSTEMS

TYPICAL PROBLEMS: Erosion-corrosion and chemical attack damage to components of HVAC units.

POTENTIAL SOLUTIONS: Belzona 1000, 2000, 3000, 4000 and 5000 series paste- and fluid-grade materials for the metal rebuilding, concrete restoration and erosion-corrosion protection of boilers, air handlers, diesel engines, fans, pumps, condensers, generators, compressors, basins of cooling towers and basins
