Baseline Assessment - Stream Attributes

Reach S-A34 (Pipeline ROW)

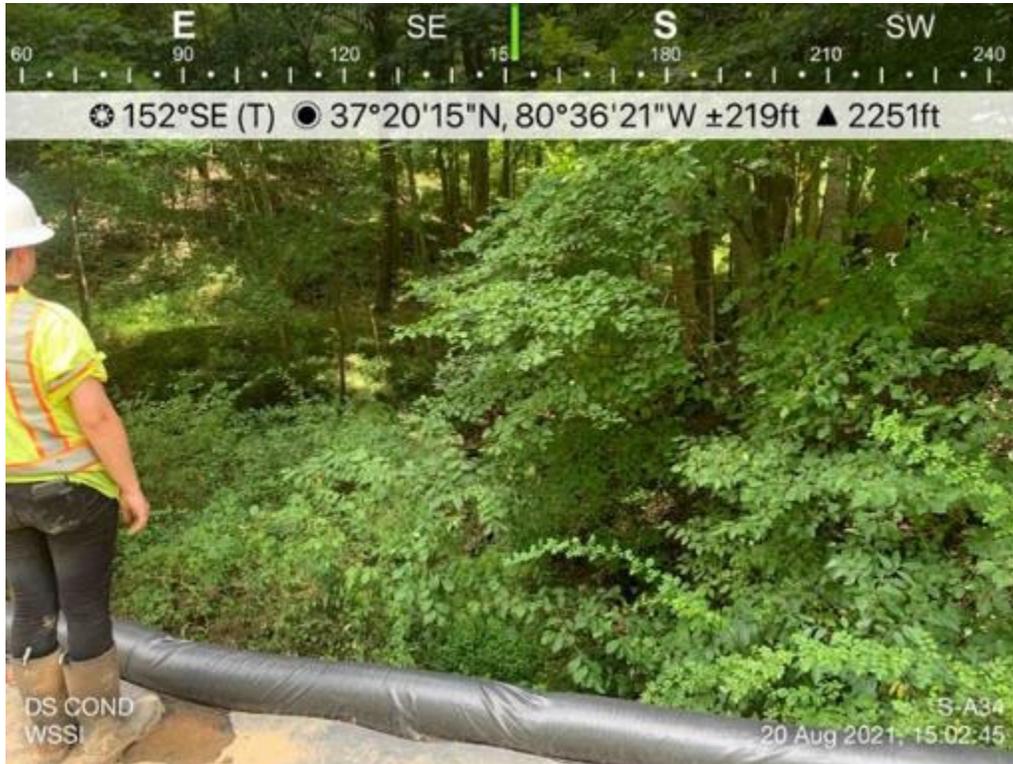
Location, Orientation, Photographer Initials: Standing on RB looking at LB along pipe centerline looking SE, KD
