## Baseline Assessment – Stream Attributes

### Reach S-H17 (Pipeline ROW) Intermittent Spread I Franklin County, Virginia

| Project Name: <b>Mountain Valley Pipeline</b> | Longitude/UTM Easting: <b>-79.662987</b> |
| Location: <b>Franklin, Spread I, Dinner Creek</b> | Sampling Date: <b>8/24/2021</b> |

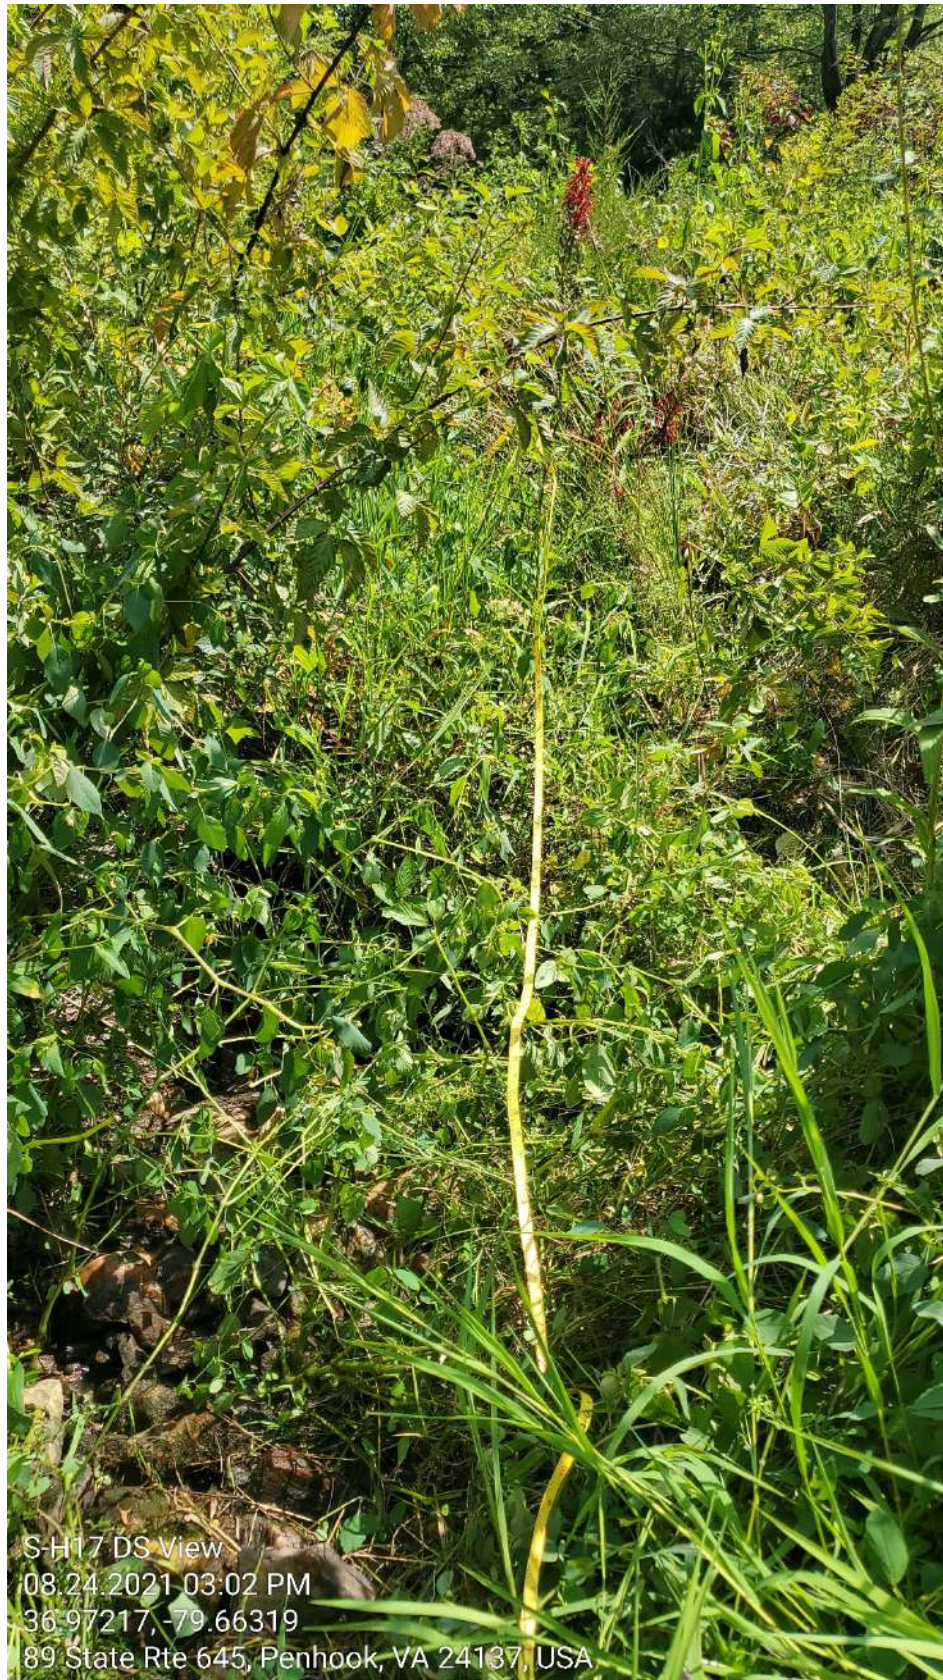
Photo Type: DS VIEW

Location, Orientation, Photographer Initials: Downstream view of ROW/LOD looking S, DW

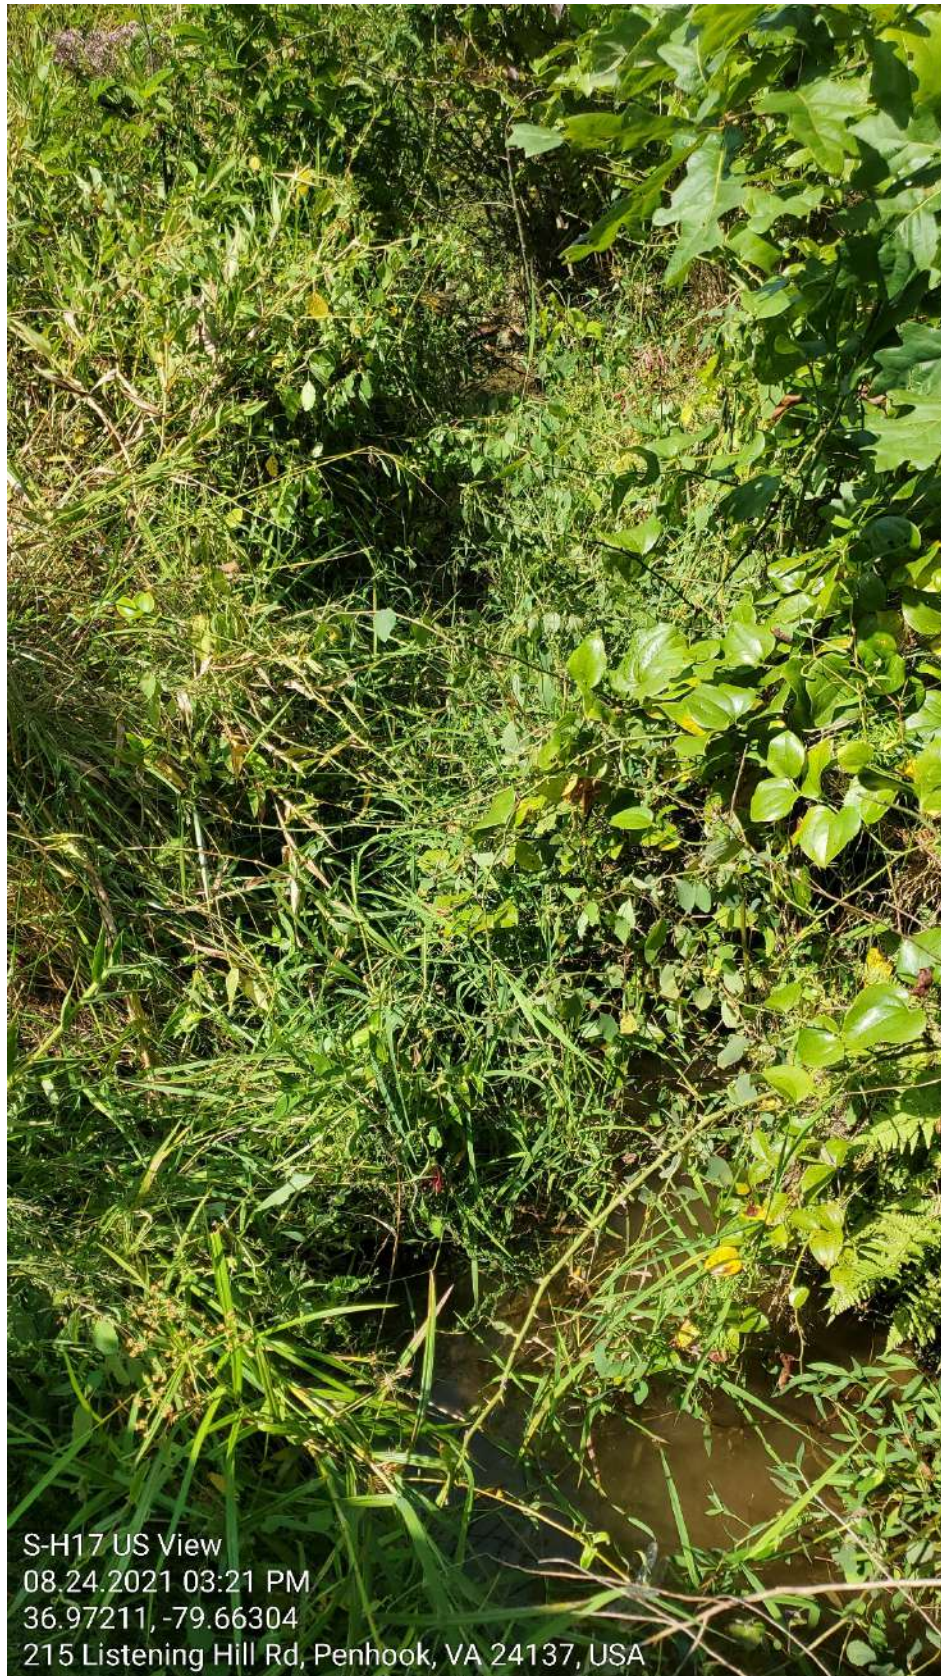
Photo Type: US VIEW

S-H17 US View  
08.24.2021 03:21 PM  
36.97211, -79.66304  
215 Listening Hill Rd, Penhook, VA 24137, USA

Location, Orientation, Photographer Initials: Upstream view of ROW/LOD looking N, DW

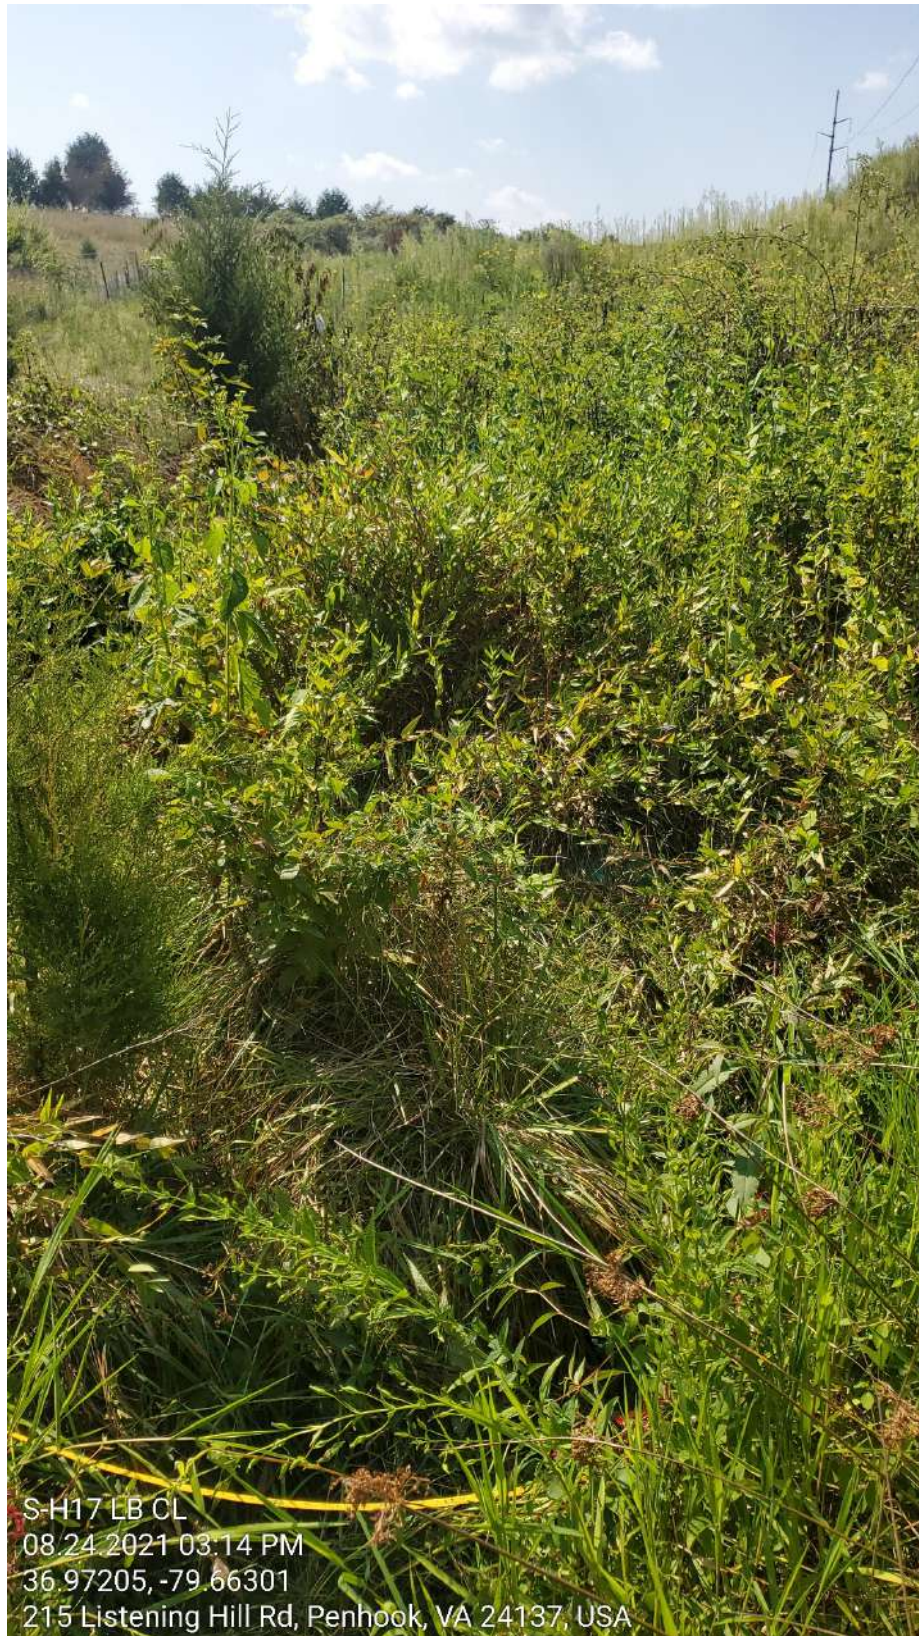
Photo Type: LB CL

Location, Orientation, Photographer Initials: Standing on LB looking at RB along pipe centerline looking W, DW

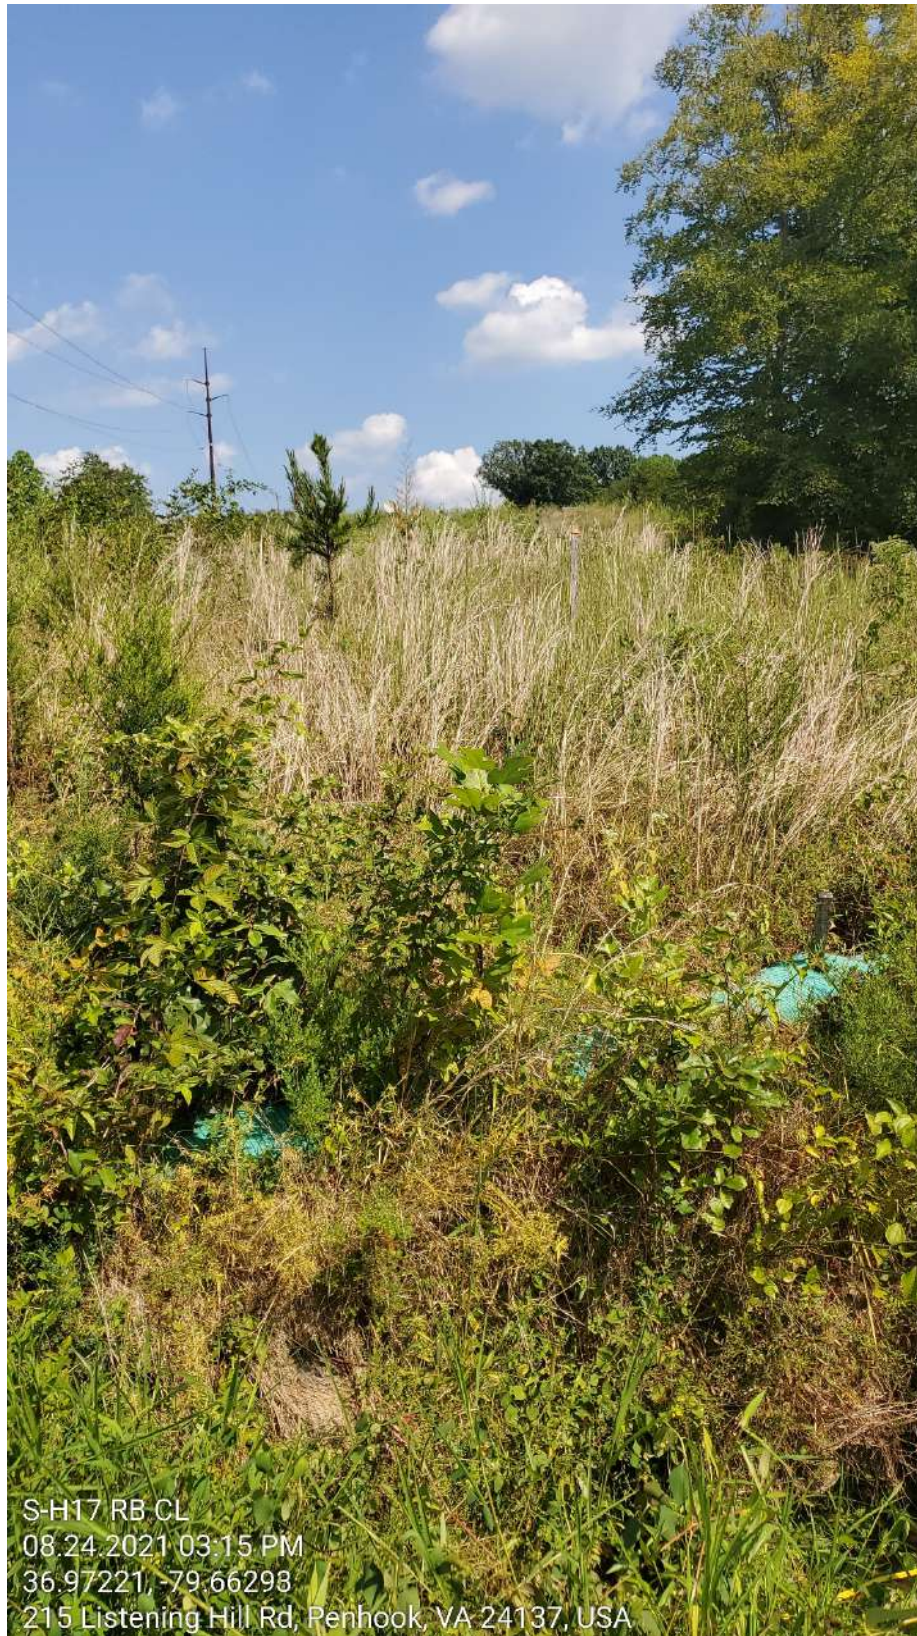
Photo Type: RB CL

Location, Orientation, Photographer Initials: Standing on RB looking at LB along pipe centerline looking E, DW

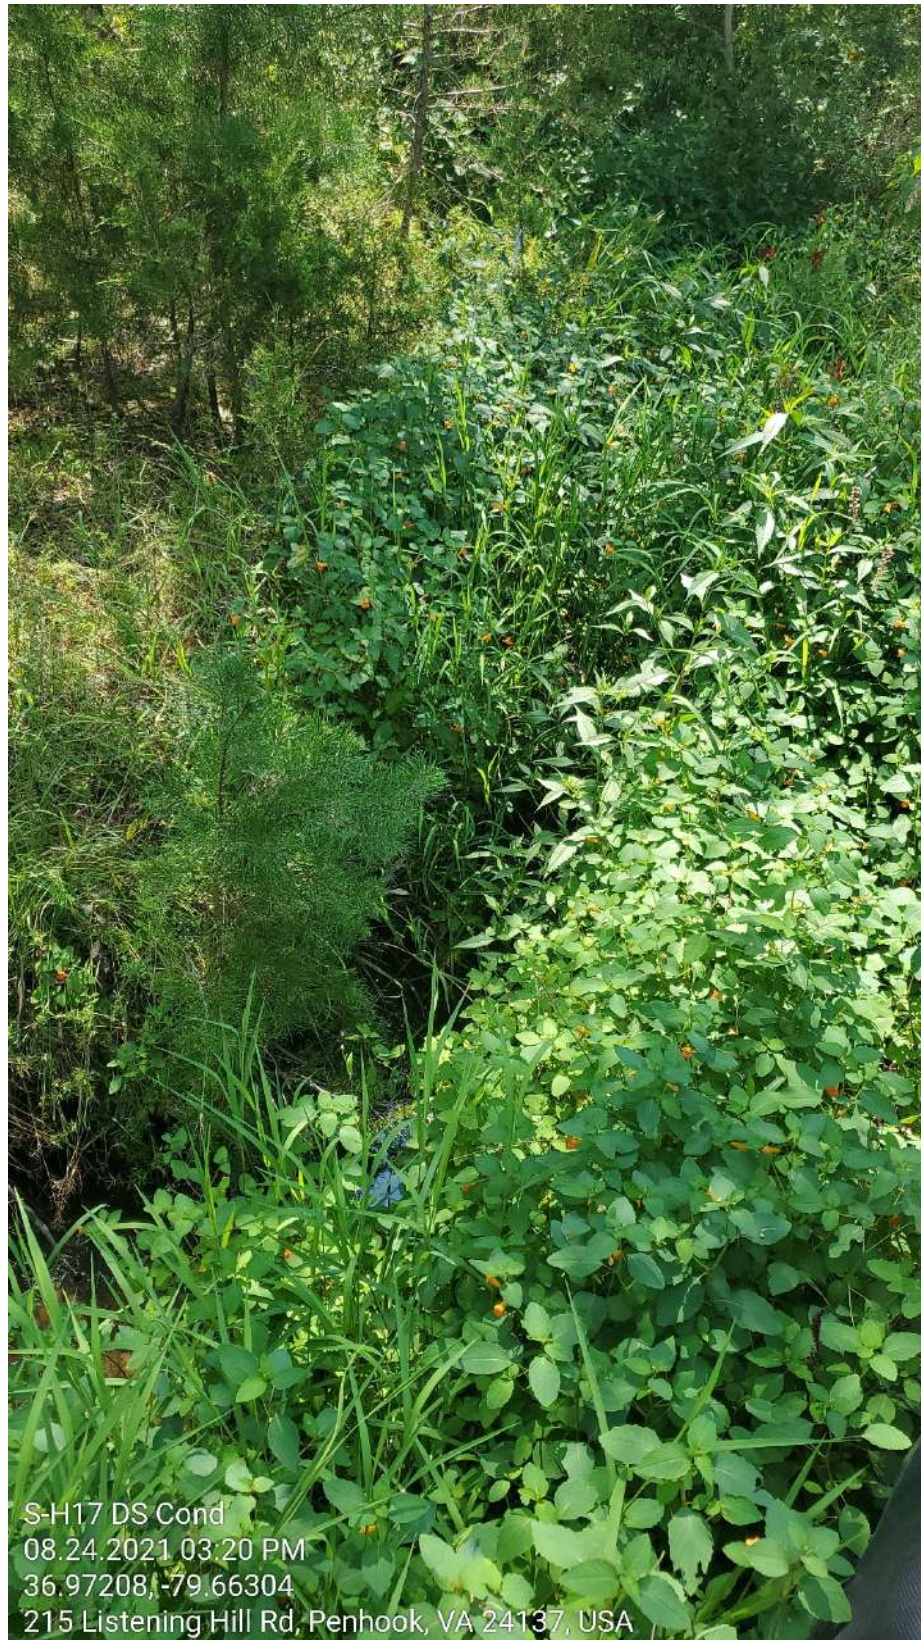
Photo Type: DS COND

Location, Orientation, Photographer Initials: Downstream conditions outside of ROW/LOD looking S, DW

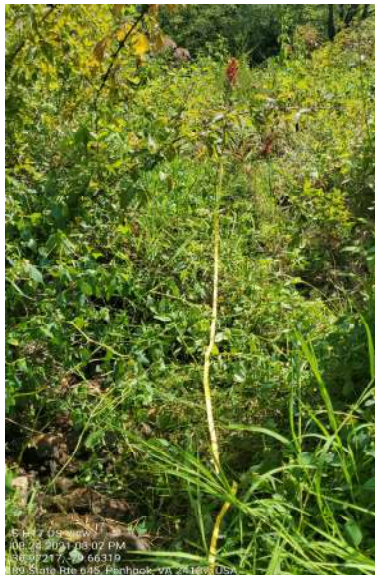
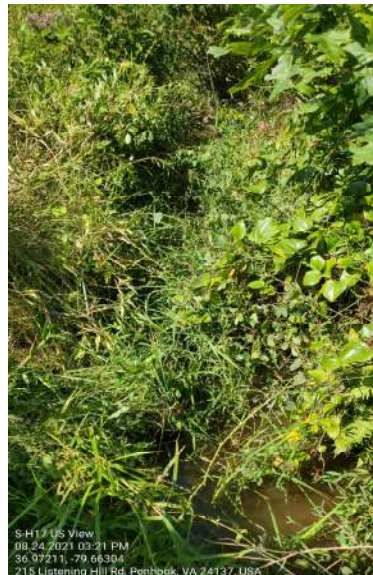
**CAPTION.** Assessment is limited to areas within the temporary ROW.

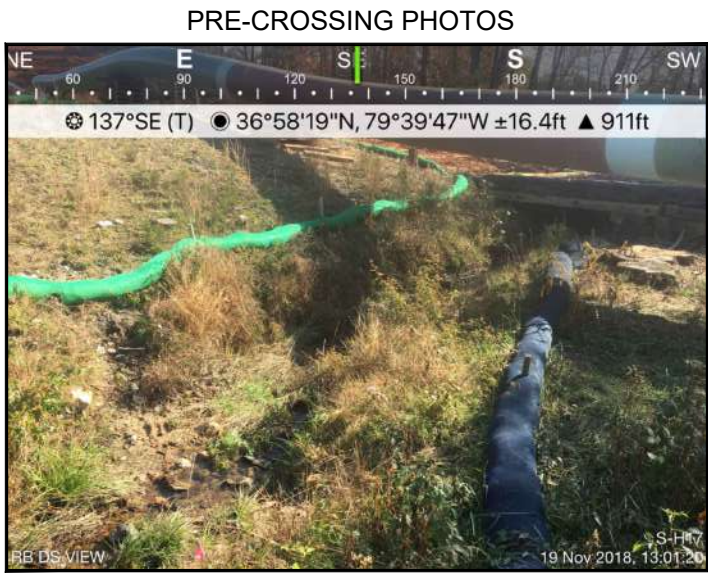
PHOTO TAKEN FROM RIGHT BANK LOOKING DOWNSTREAM TO THE SOUTHEAST ON 11/19/2018

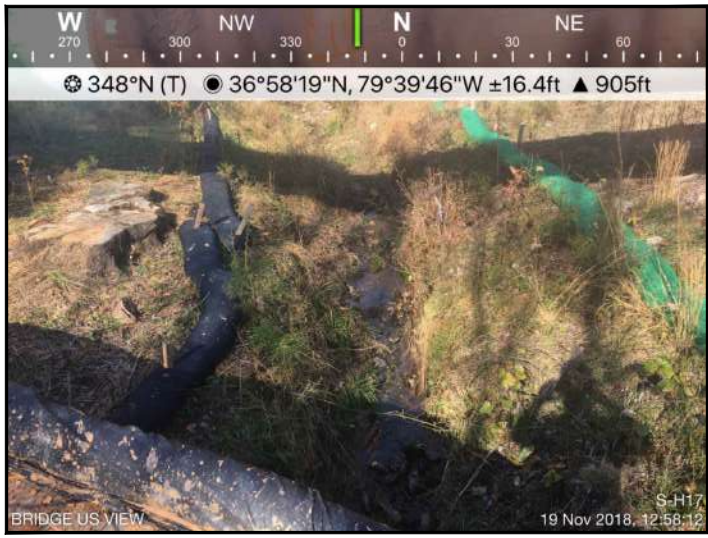
PHOTO TAKEN FROM BRIDGE LOOKING UPSTREAM TO THE NORTH ON 11/19/2018

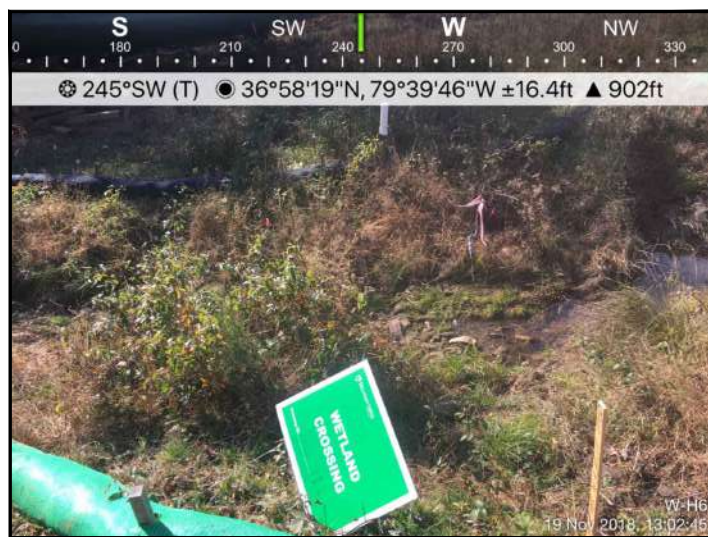
PHOTO TAKEN LOOKING AT W-H6 FROM LEFT BANK OF S-H17 ON 11/19/2018
