CLIENT:
Brockton Apartments

PROJECT TITLE:
175 Catherine St S
Hamilton, On

SHEET TITLE:
Tree Protection Plan

DWG No. L2 DRAWN BY: JJ
SHEET No. 2 of 2 DESIGN BY: LWS and JJ
PROJECT No: 22-072 CHECKED BY: LWS
SCALE: As shown NORTH ARROW:

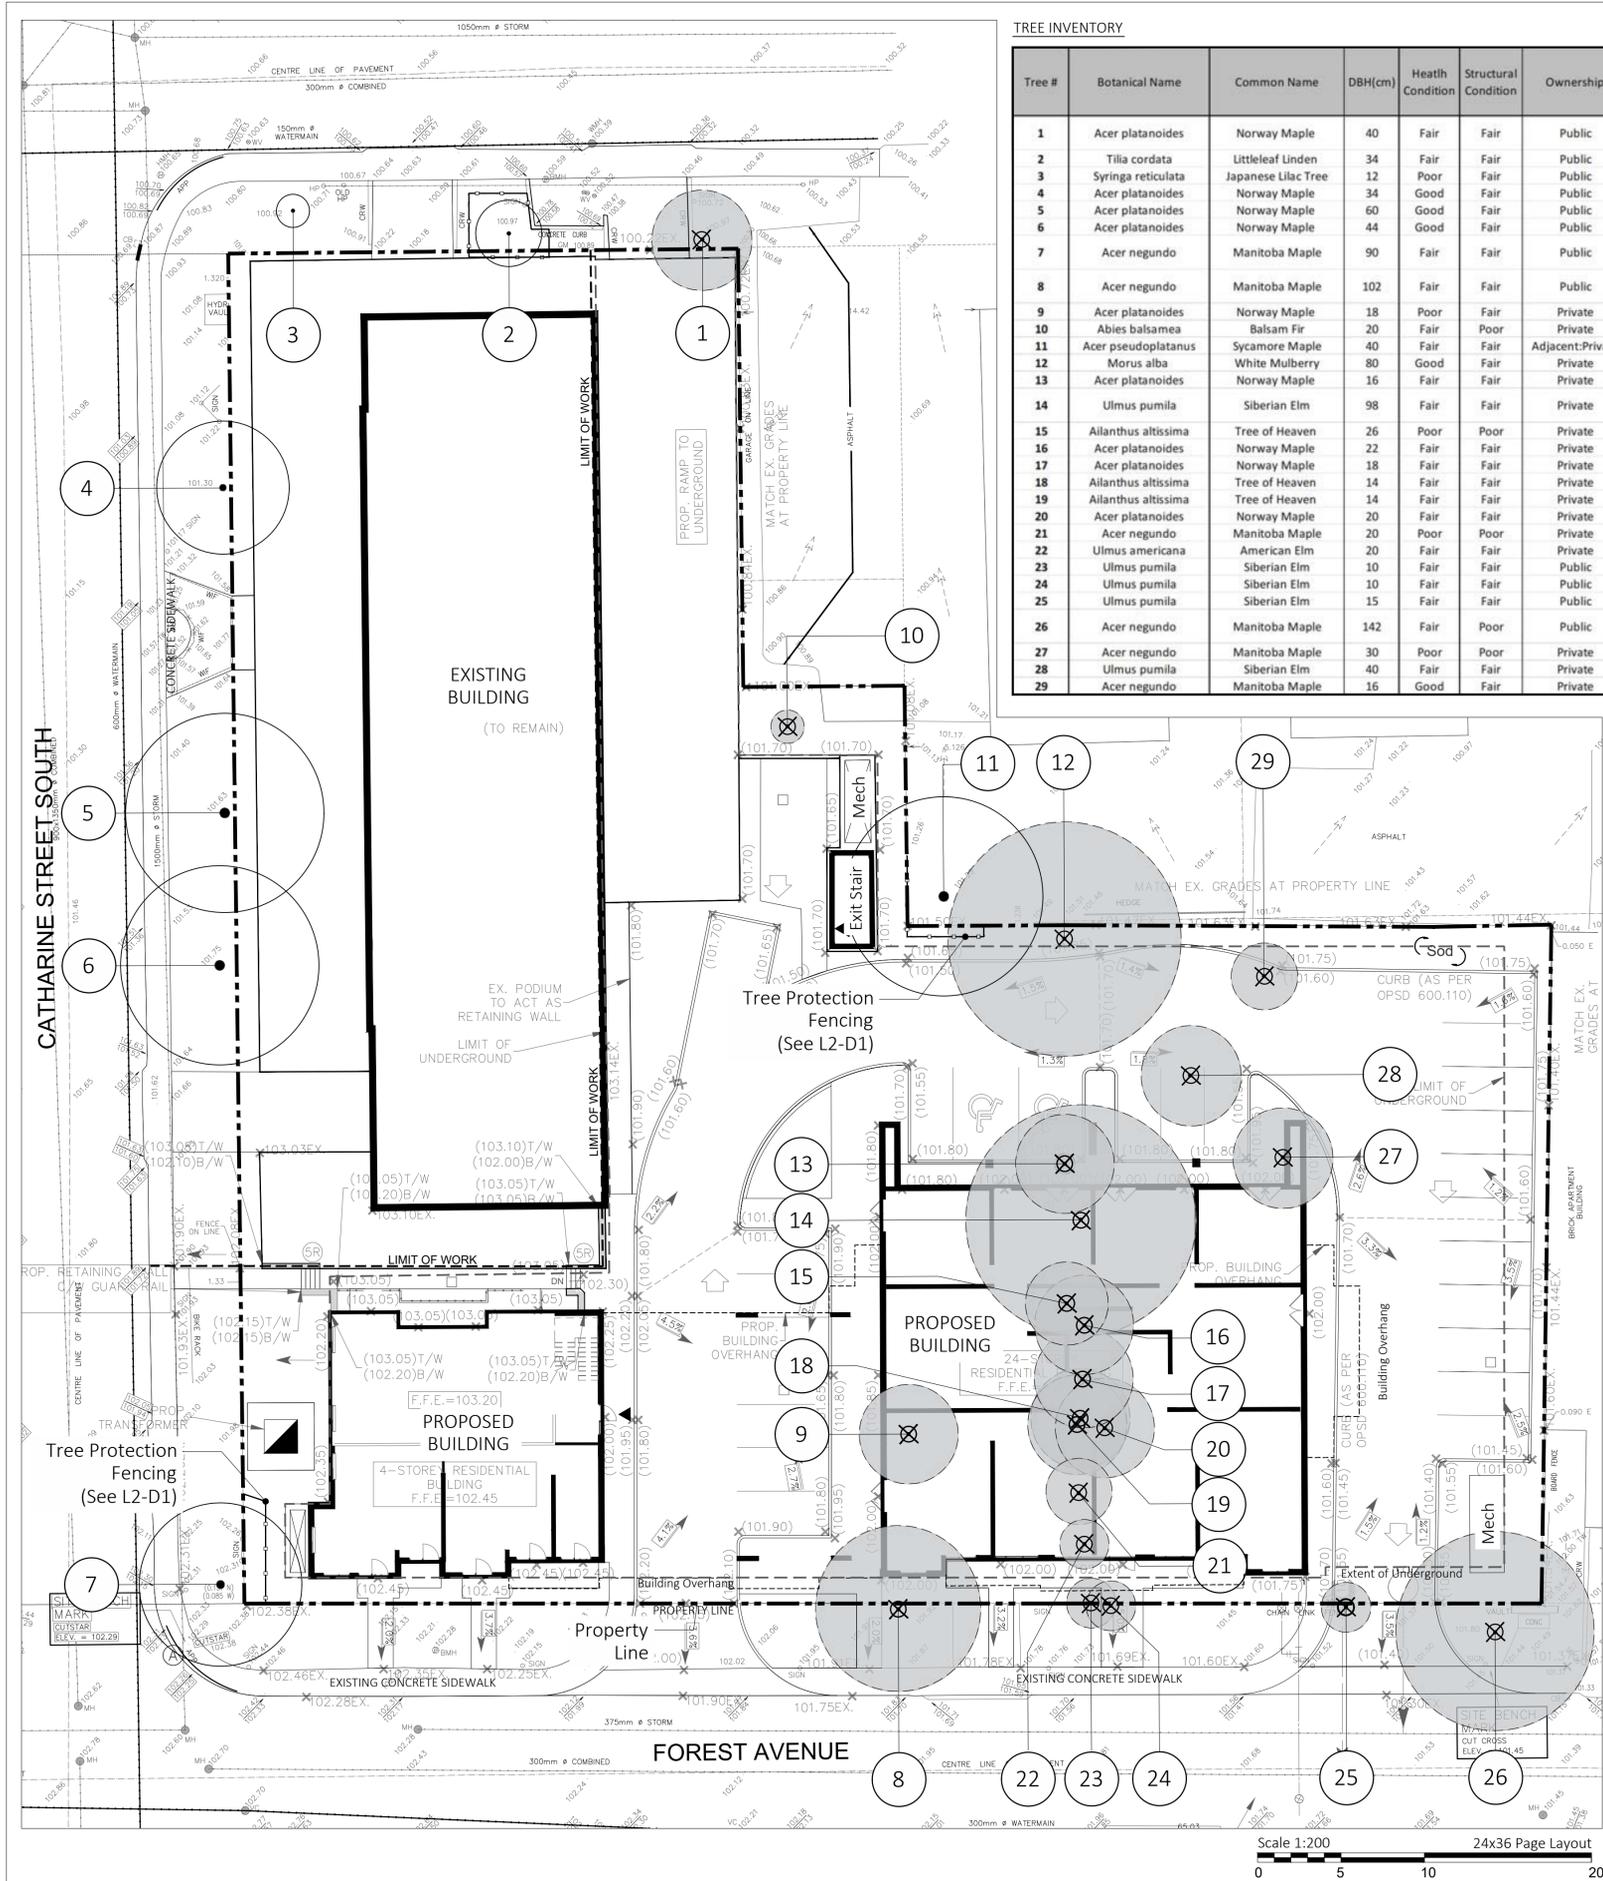
Tree #	Botanical Name	Common Name	DBH(cm)	Health Condition	Structural Condition	Ownership	Comments	Recommendation: Rationale
1	Acer platanoides	Norway Maple	40	Fair	Fair	Public		Remove: Tree proximity to proposed ramp precludes preservation.
2	Tilia cordata	Littleleaf Linden	34	Fair	Fair	Public		Retain
3	Syringa reticulata	Japanese Lilac Tree	12	Poor	Fair	Public		Retain
4	Acer platanoides	Norway Maple	34	Good	Fair	Public		Retain
5	Acer platanoides	Norway Maple	60	Good	Fair	Public		Retain
6	Acer platanoides	Norway Maple	44	Good	Fair	Public		Retain
7	Acer negundo	Manitoba Maple	90	Fair	Fair	Public	Multi Stem 30,24,16,20	Retain
8	Acer negundo	Manitoba Maple	102	Fair	Fair	Public	Multi Stem 34,38,30	Remove: Trees dripline within building footprint.
9	Acer platanoides	Norway Maple	18	Poor	Fair	Private		Remove: Tree within building footprint.
10	Abies balsamea	Balsam Fir	20	Fair	Poor	Private		Remove: Tree within proposed servicing.

11	Acer pseudoplatanus	Sycamore Maple	40	Fair	Fair	Adjacent-Private		Retain
12	Morus alba	White Mulberry	80	Good	Fair	Private		Remove: Tree within proposed retaining wall.
13	Acer platanoides	Norway Maple	16	Fair	Fair	Private		Remove: Tree within internal walkway.
14	Ulmus pumila	Siberian Elm	98	Fair	Fair	Private	Twin Stem 48,50	Remove: Tree within building footprint.
15	Allanthus altissima	Tree of Heaven	26	Poor	Poor	Private		Remove: Tree within building footprint.
16	Acer platanoides	Norway Maple	22	Fair	Fair	Private		Remove: Tree within building footprint.
17	Acer platanoides	Norway Maple	18	Fair	Fair	Private		Remove: Tree within building footprint.
18	Allanthus altissima	Tree of Heaven	14	Fair	Fair	Private		Remove: Tree within building footprint.
19	Allanthus altissima	Tree of Heaven	14	Fair	Fair	Private		Remove: Tree within building footprint.
20	Acer platanoides	Norway Maple	20	Fair	Fair	Private		Remove: Tree within building footprint.

21	Acer negundo	Manitoba Maple	20	Poor	Poor	Private		Remove: Tree within building footprint.
22	Ulmus americana	American Elm	20	Fair	Fair	Private		Remove: Tree within building footprint.
23	Ulmus pumila	Siberian Elm	10	Fair	Fair	Public		Remove: Trees dripline within building footprint.
24	Ulmus pumila	Siberian Elm	10	Fair	Fair	Public		Remove: Trees dripline within building footprint.
25	Ulmus pumila	Siberian Elm	15	Fair	Fair	Public		Remove: Trees dripline within building footprint.
26	Acer negundo	Manitoba Maple	142	Fair	Poor	Public	Multi Stem 50,38,24,30	Remove: Trees dripline within proposed roadway.
27	Acer negundo	Manitoba Maple	30	Poor	Poor	Private		Remove: Tree within internal sidewalk.
28	Ulmus pumila	Siberian Elm	40	Fair	Fair	Private		Remove: Tree within internal roadway.
29	Acer negundo	Manitoba Maple	16	Good	Fair	Private		Remove: Tree within proposed asphalt parking.

Qty	Tree Removal Statement and Compensation Statement
12	Twelve municipal trees were inventoried as part of this application. Of those twelve, six are to be retained and six are recommended for removal.
17	Seventeen private trees were inventoried through topographic survey and arborist verification as part of this application. Sixteen trees are proposed for removal. The remaining 1 tree is to be protected and retained. Therefore, compensation of 1:1 will be 16.

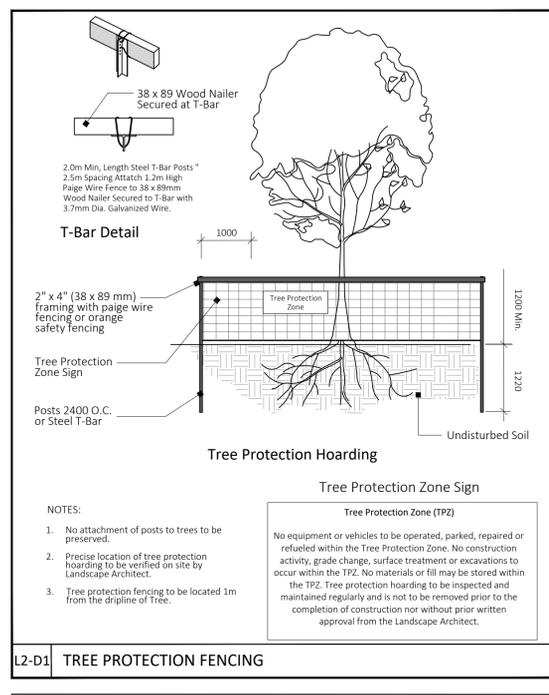
L2-D1 TREE PROTECTION FENCING

NOTE (1): A Verification of Tree Protection letter will be prepared by the tree management professional and submitted to the satisfaction of the City's Director of Planning, to confirm that all tree protection measures have been installed correctly.
