CONCRETE BLOCK PAVING

Technical note for steep slopes

1. CONSTRUCTION OF STEEP SLOPES

2. CAPE TOWN – CASE STUDY

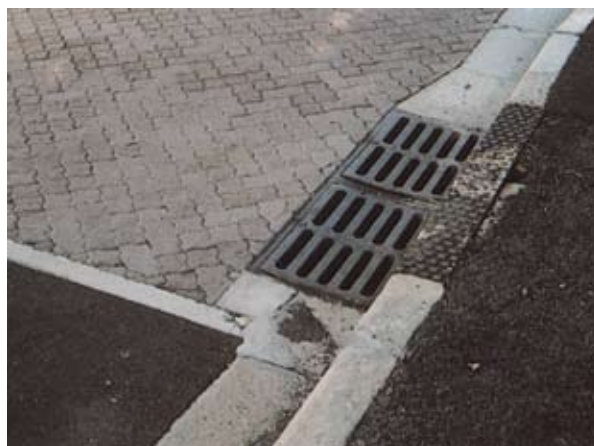
Photograph 5 – Anchor beam in Avenue Charmante

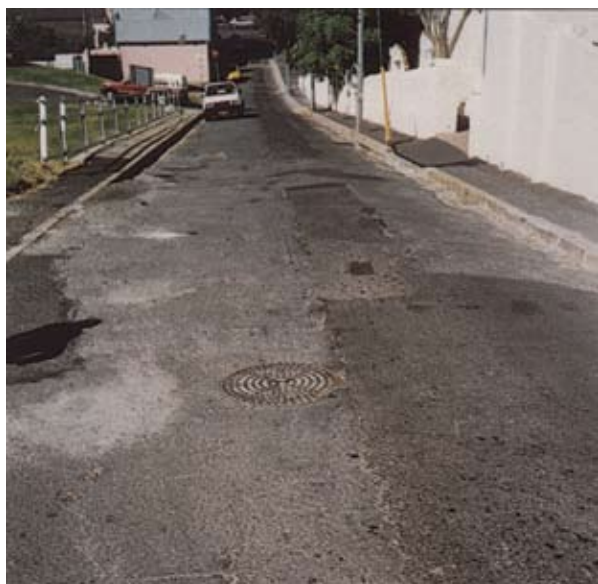
Photograph 8 – Upper Rhine Road - section still to be rehabilitated

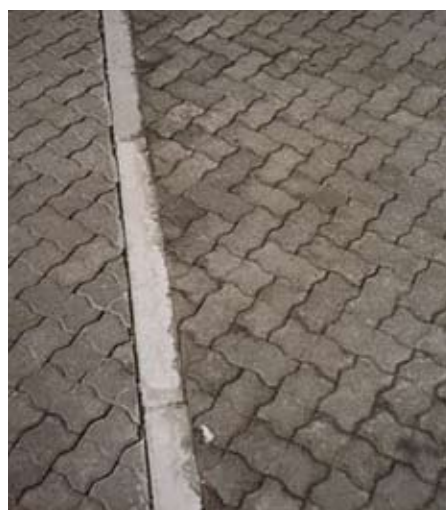
Photograph 1
– Anchor beam, showing gap due to creep of blocks immediately downside of anchor beam

As a result of the forces described previously, there could be a small amount of horizontal creep and sliding of the blocks due to the horizontal consolidation of the jointing sand. This could result in an opening up of the top edge joint.

Although this gap does not affect the structural integrity of the pavement, it does need addressing as it can lead to ingress of water. Typically, the pavement should be monitored after 3-6 months, and if a joint has opened up, it should be filled with jointing sand or a bitumen sealant.

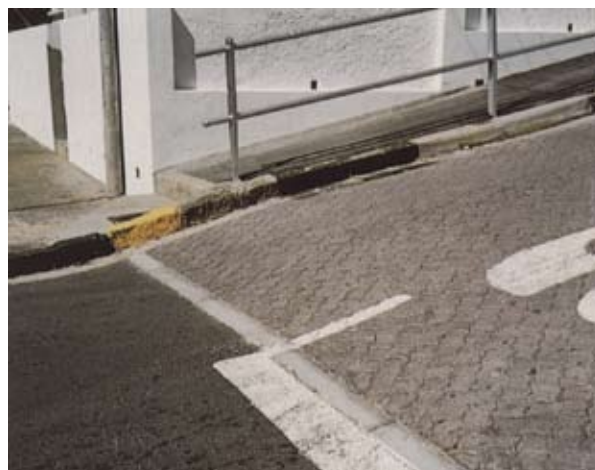
Photograph 3 – Anchor beam at bottom of Upper Rhine Road
