## TEST REPORT

No.: GZIN2512002317CM02\_EN

Sample Name : ECONICLAY COVERING

Manufacturer : PHOMI MCM CO., LTD.

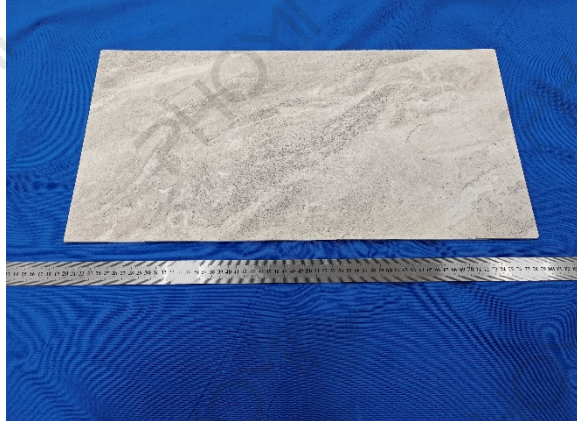
| Sample - stone | Adhesive – Provided by client |
