123 Example Address Avenue, Christchurch  
Building Report

22/04/2026

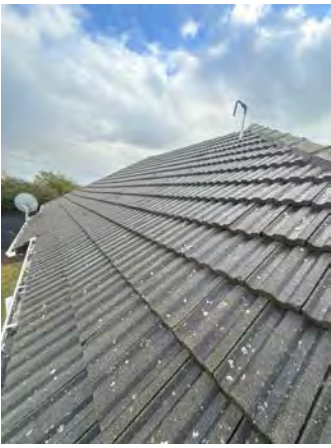
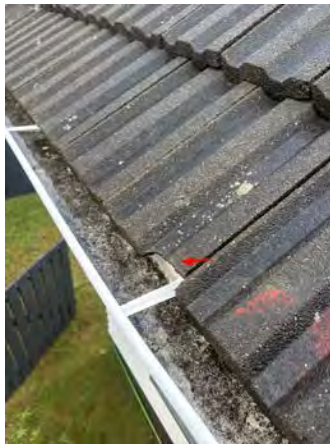
Chip in tile.

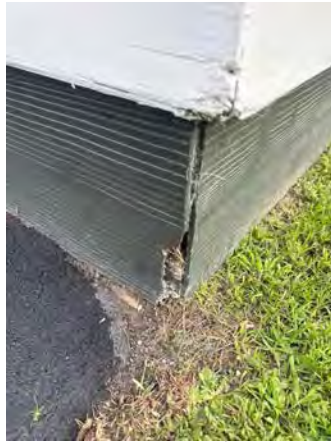
Some chips to sheet that is used as the sub floor access.

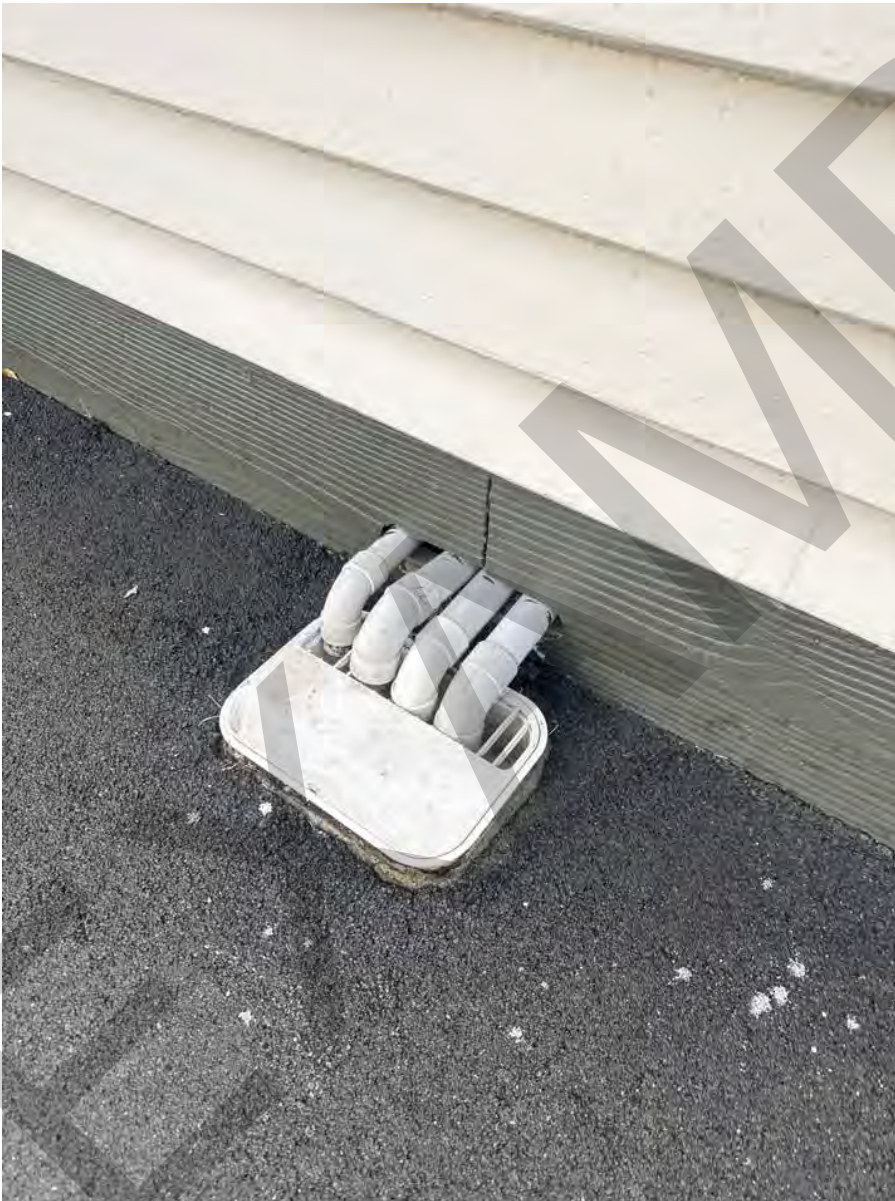
Gully trap is sufficient height off finished ground level. Trap is configured properly and does not have downpipes directing stormwater into it. Grate installed on trap to prevent debris getting into the grey water system.

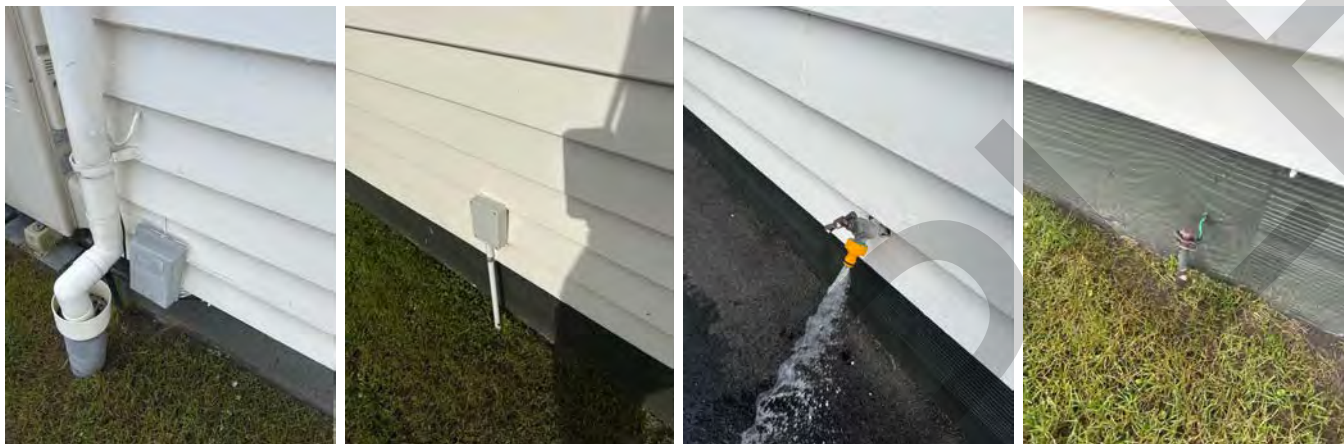
Tap is operating fine.

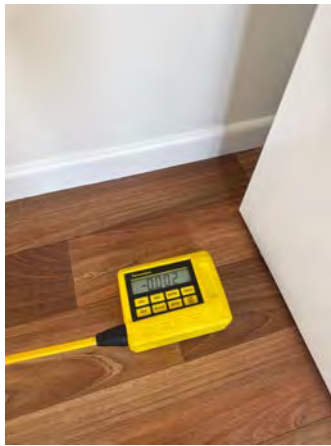
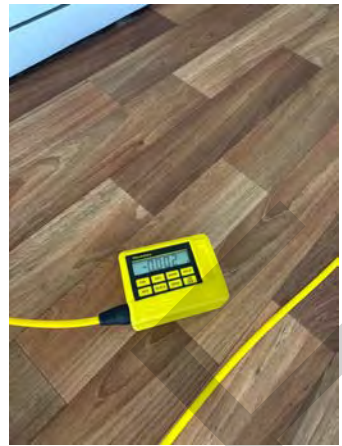
The floor levels slightly exceed the MBIE guidelines for slope exceeding 0.5% in the eastern bedroom and the living room. We did not note anything that appeared concerning on the superstructure corresponding with these deviations however there are areas noted in the sub floor space of this report that need addressing, refer to sub floor section of this report for comments.

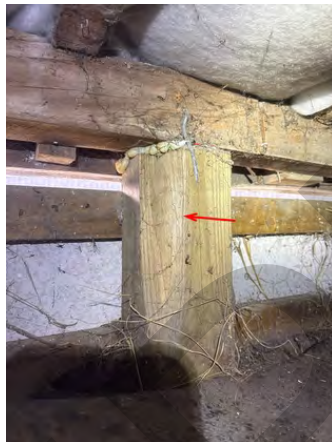
Sub floor access on the NE exterior wall.

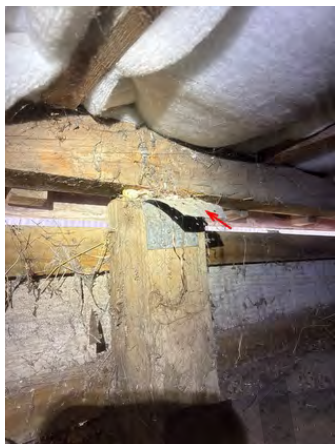
Split pile and example of precast packers.

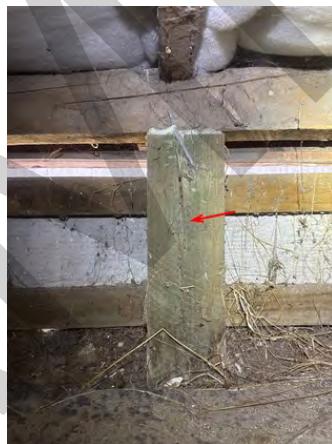
Monitor split pile.

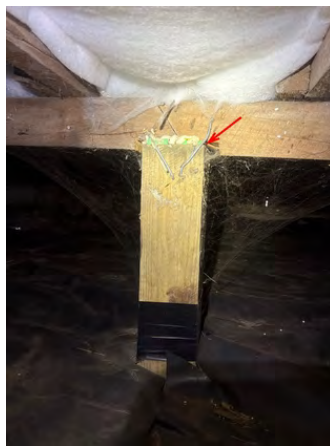
Split piles. One has been glued together.

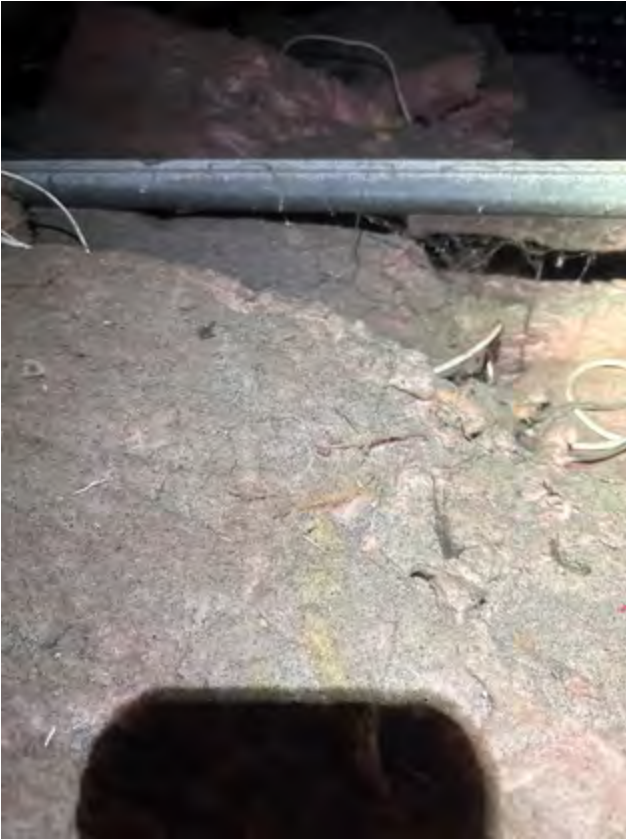
Some general aging and compressing to insulation.

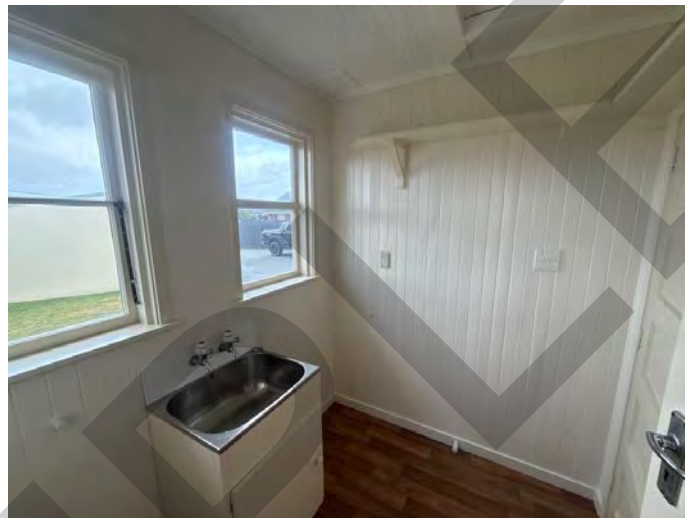
Opening and gaps by rear laundry door could be closed off to prevent draught.

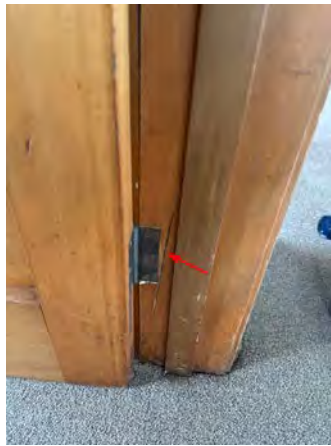
Example - many internal doors have some splitting to the panels from age.

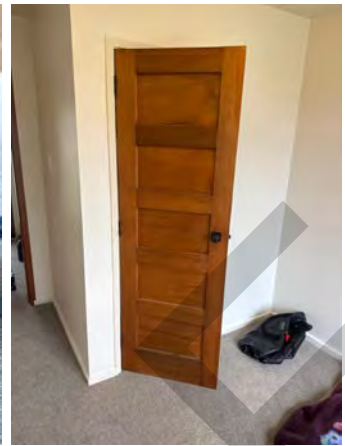
Split in reveal.
