**70345 BLUE RIDGE MOUNTAIN**

# **PLUS SEVEN INSPECTION - SAMPLE REPORT**

Inspection Type: Home Inspection

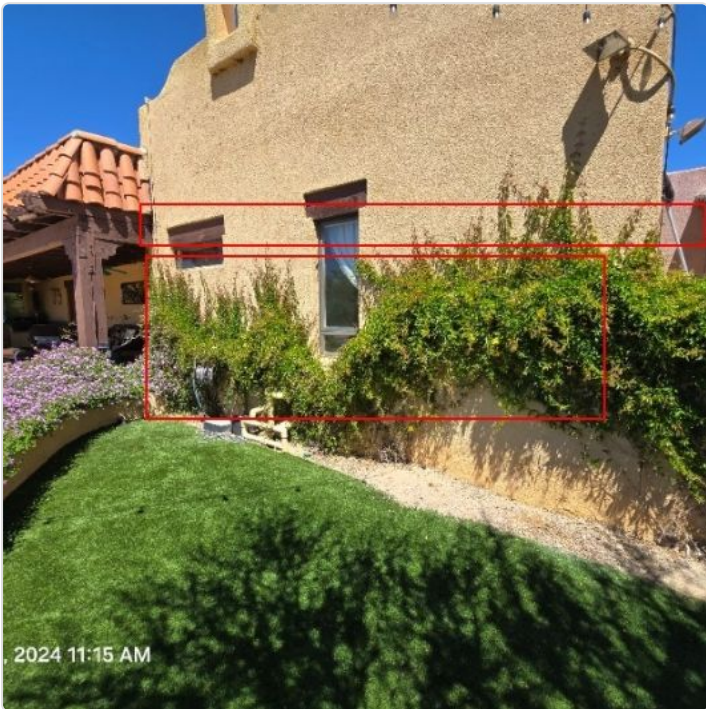
PRIOR STUCCO REPAIR NOTED

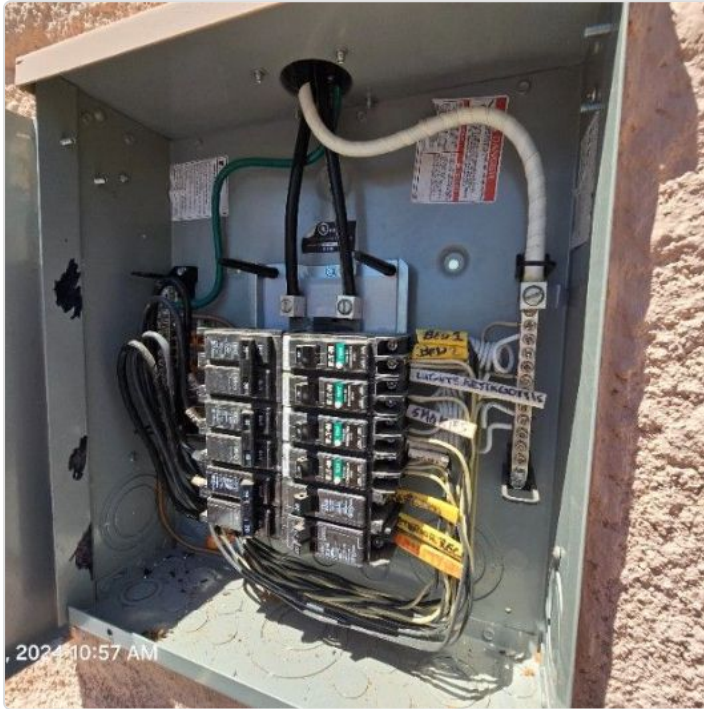
UV DAMAGED WIRING

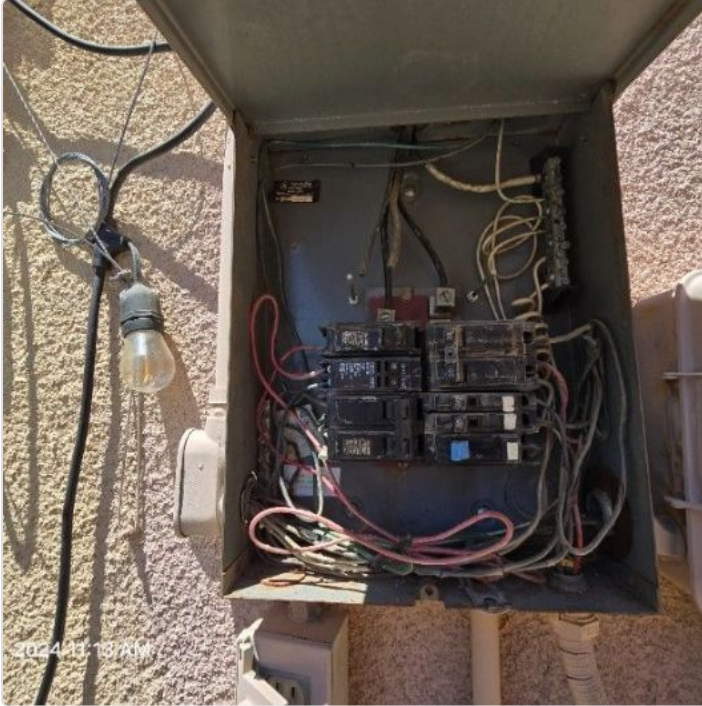
PANEL - OPEN KNOCKOUTS

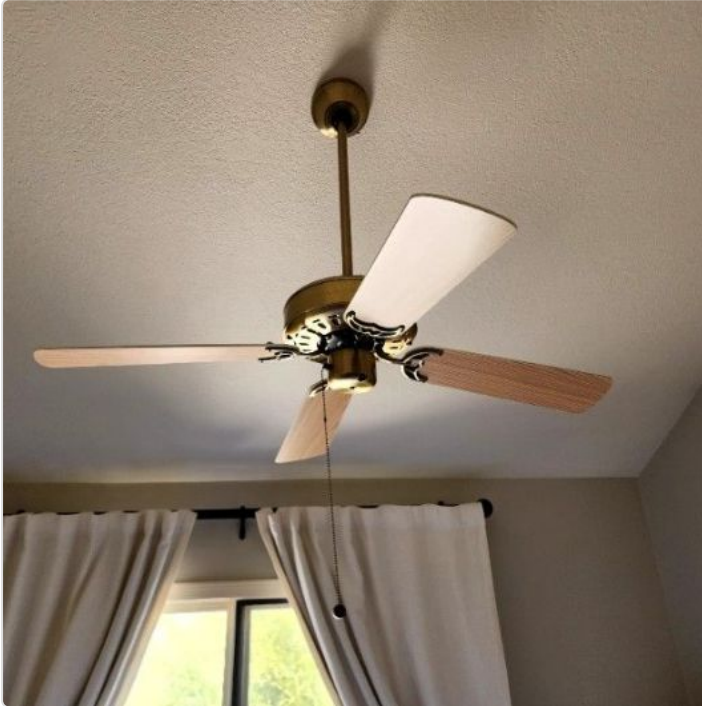
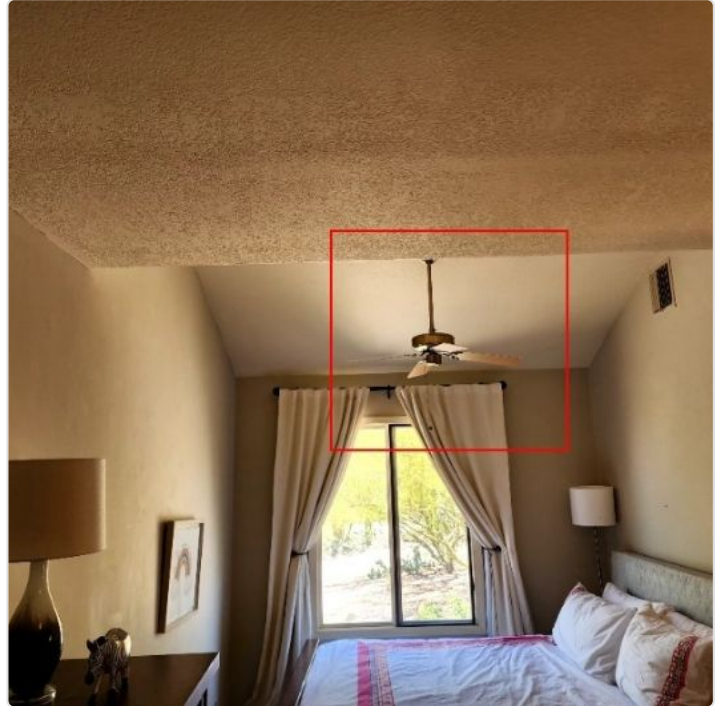
## CEILING FAN - OUT OF BALANCE

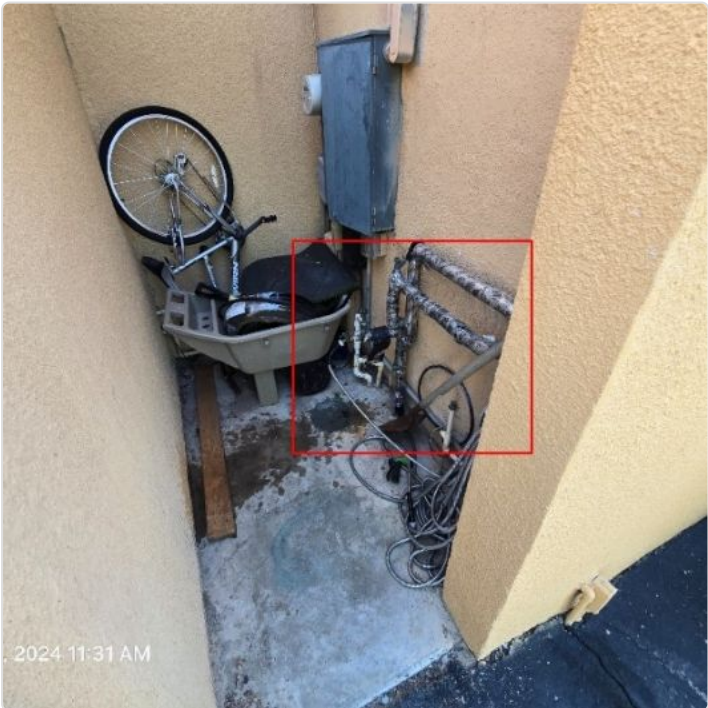
**NO SERVICE**

**Recommendation:**  
Contact a qualified plumbing contractor

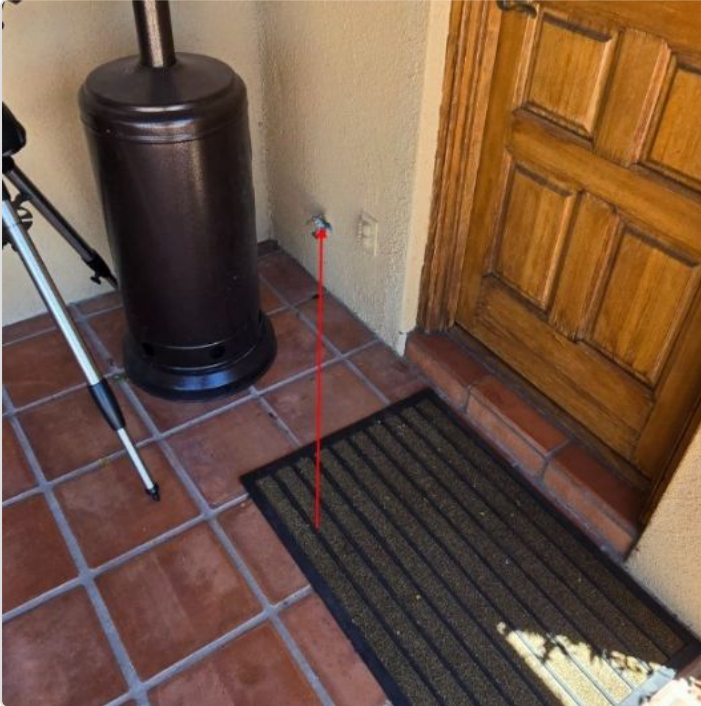
WATER LINE - CORROSION

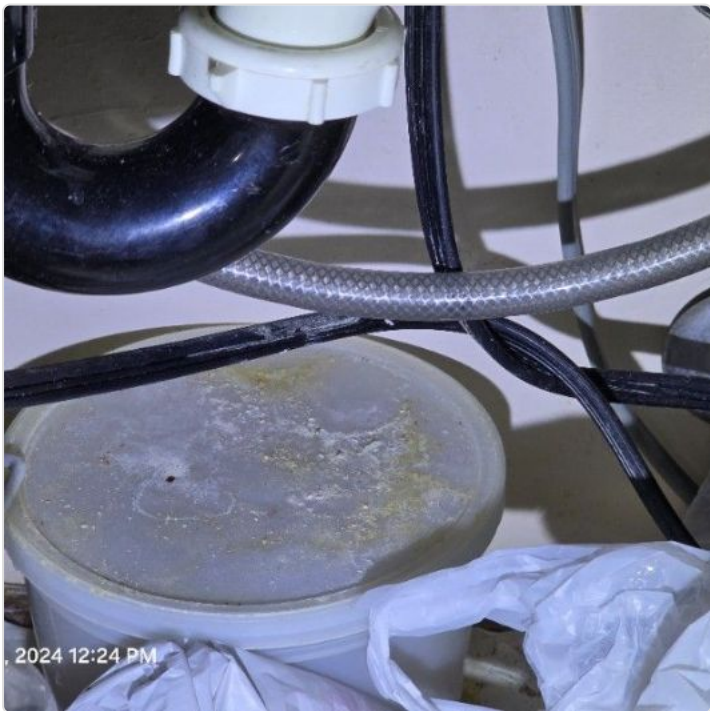
PLUMBING - CORROSION/BUILDUP
