# Technical Report – R20556-Rev 2 CWCT – Standard for systemised building envelopes – 2005

**TI Tiles International Ltd  
Aerobrick Mechanical Brickslip**

Rev 2 (Revised Report) – this report has been amended as shown in Section 10 and it replaces previous report No. R20556 dated 20<sup>th</sup> May 2020.

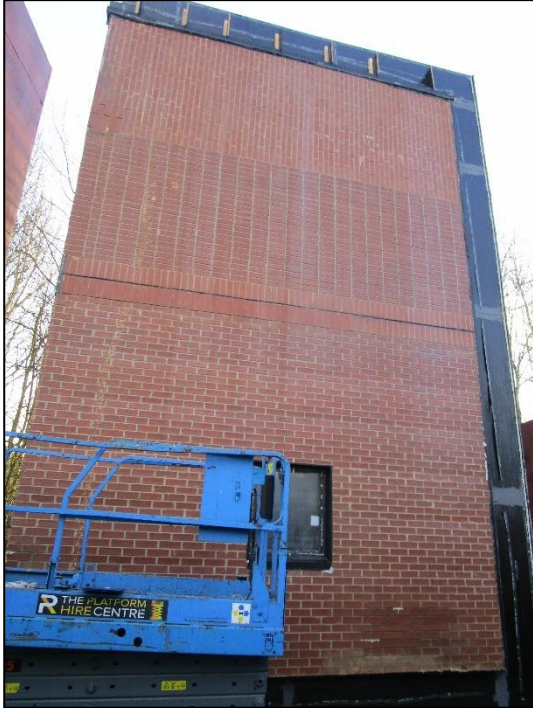
Photograph No. 14

Sample prior to dismantle

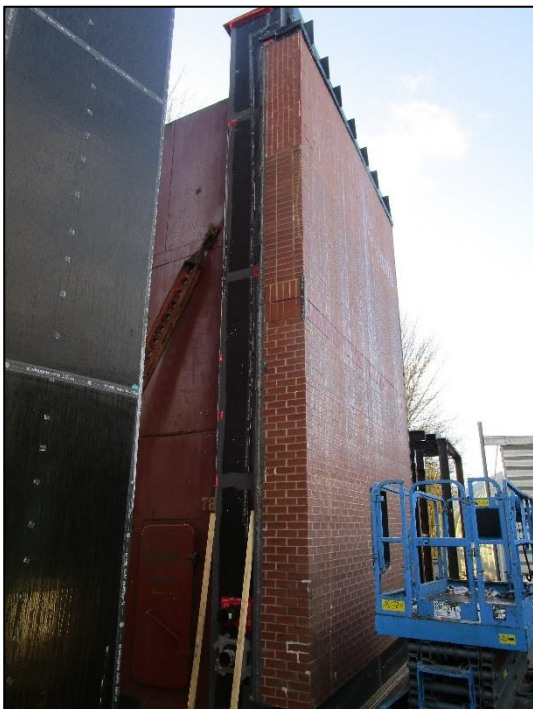
Photograph No. 15

Sample prior to dismantle

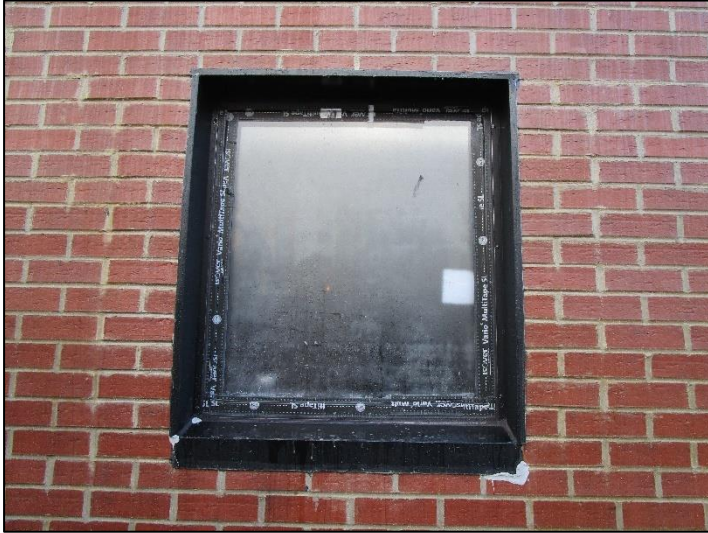
Photograph No. 16

Window pod detail

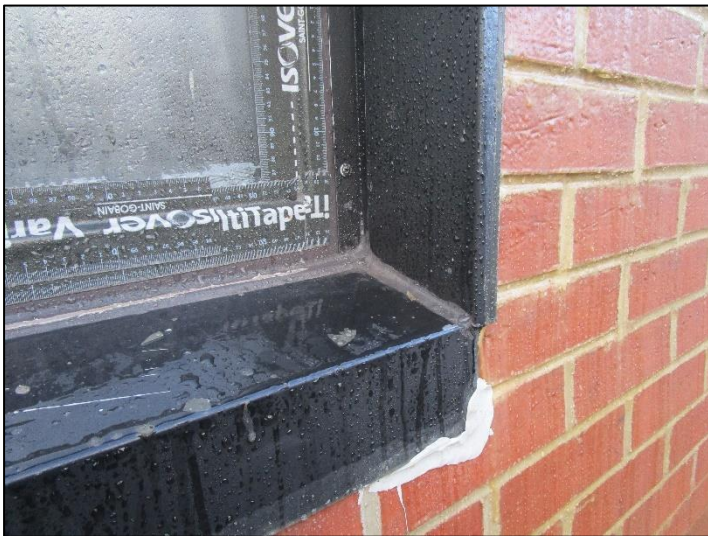
Photograph No. 17

Window pod detail

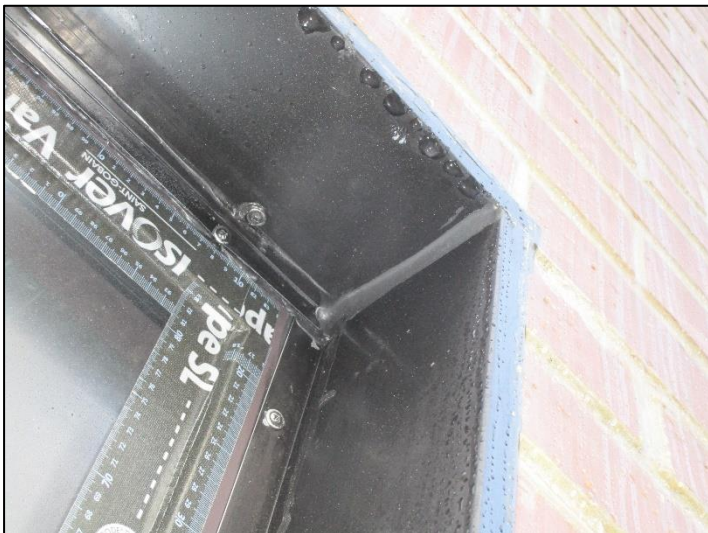
Photograph No. 18

Window pod detail

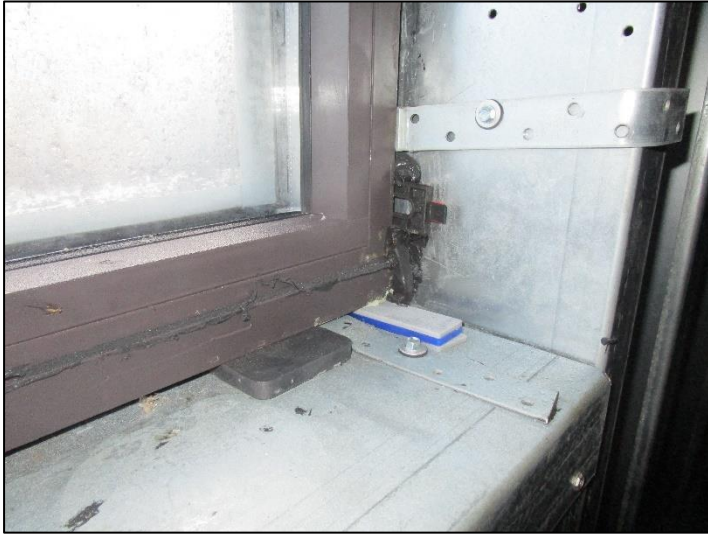
Photograph No. 19

Internal window pod detail

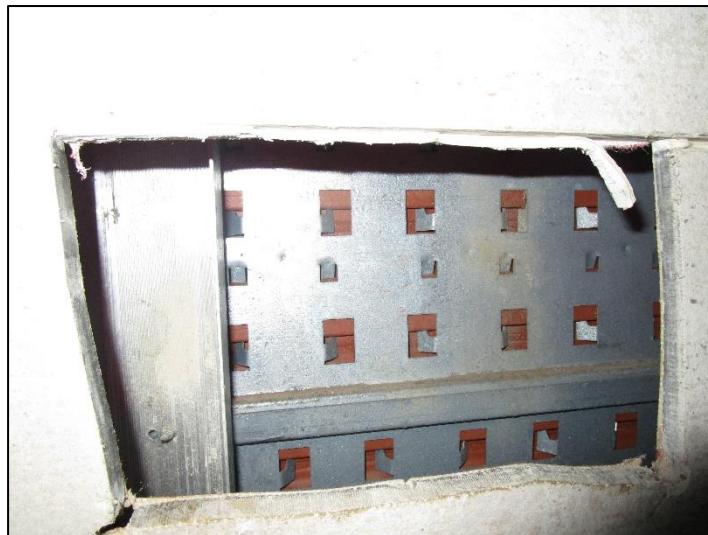
Photograph No. 21

Back section of rail and tray  
as viewed from the inside

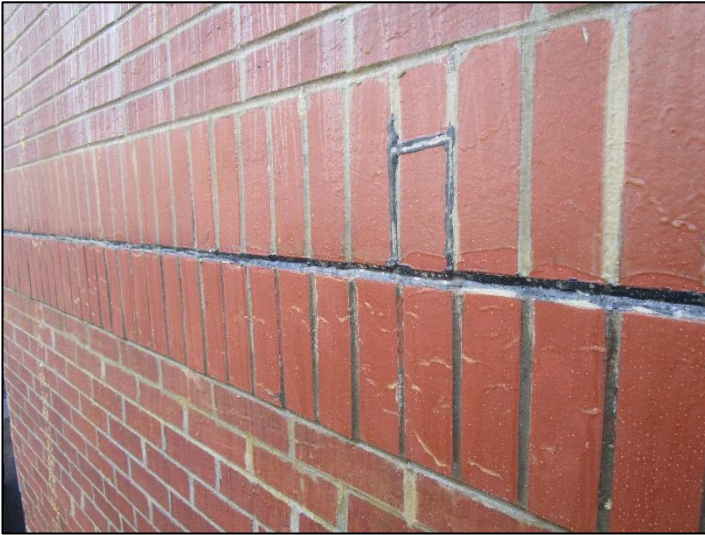
Photograph No. 22

Soldier course expansion joint

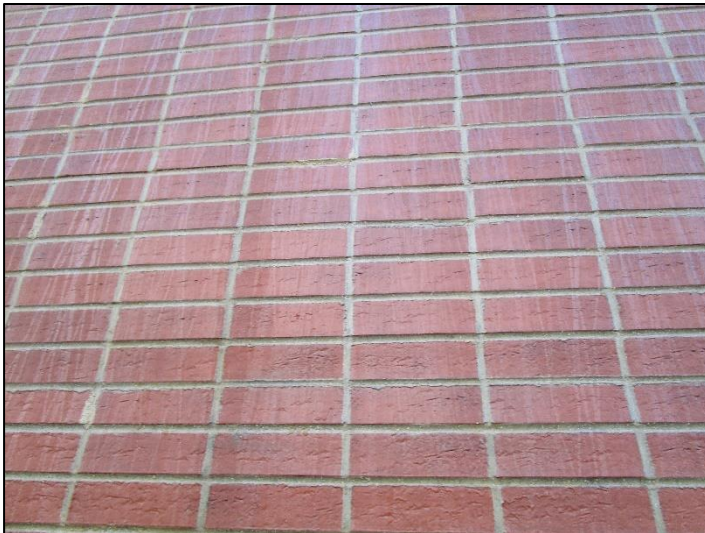
Photograph No. 23

Horizontal modular layout

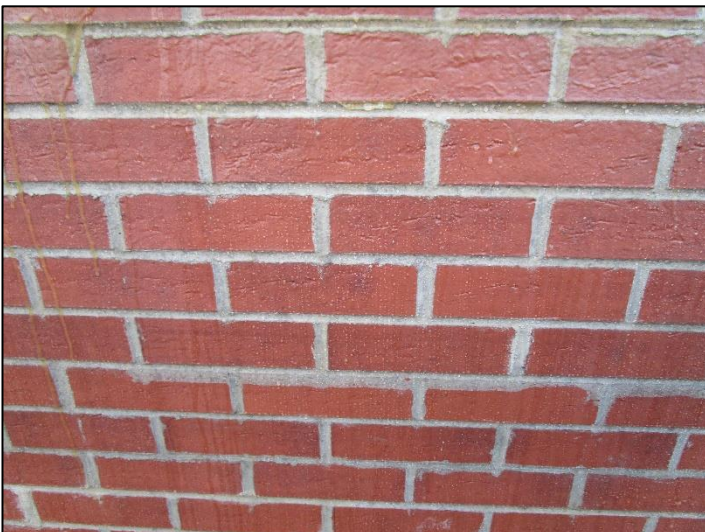
Photograph No. 24

Staggered horizontal joint layout

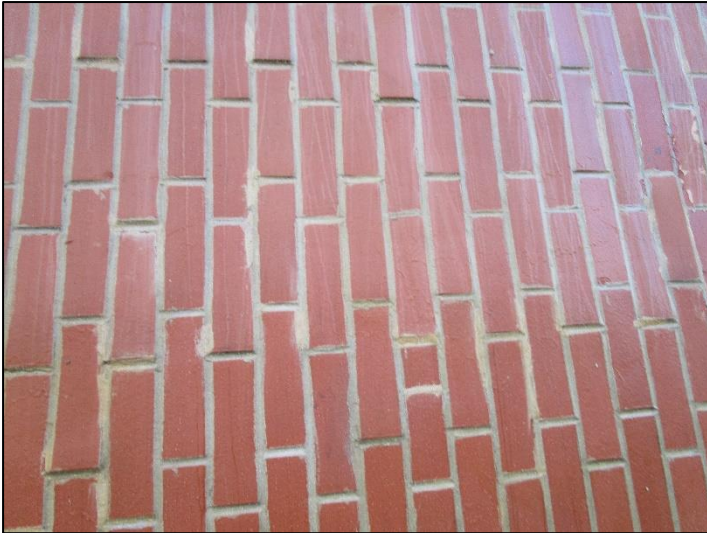
Photograph No. 25

Vertical layout

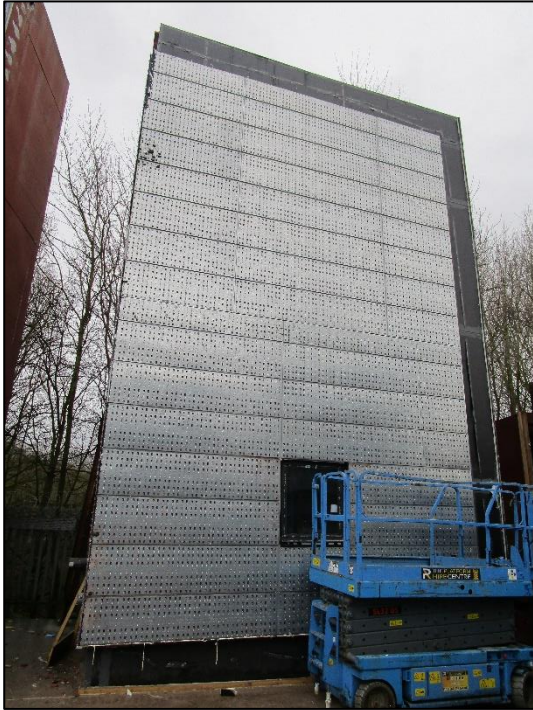
Photograph No. 28

Brick tray layout

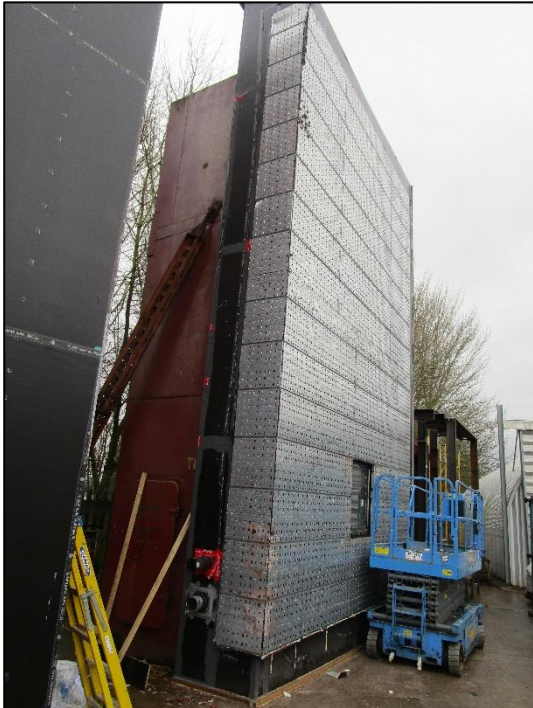
Photograph No. 29

Brick tray layout

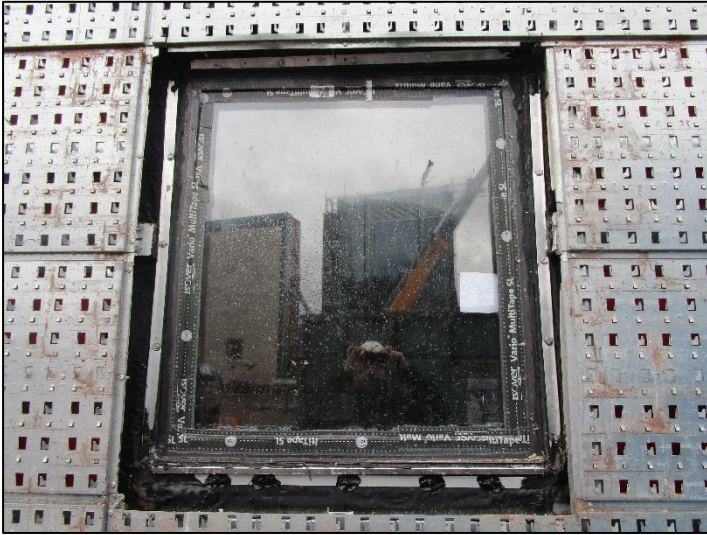
Photograph No. 30

Window pod interface to  
brick tray layout

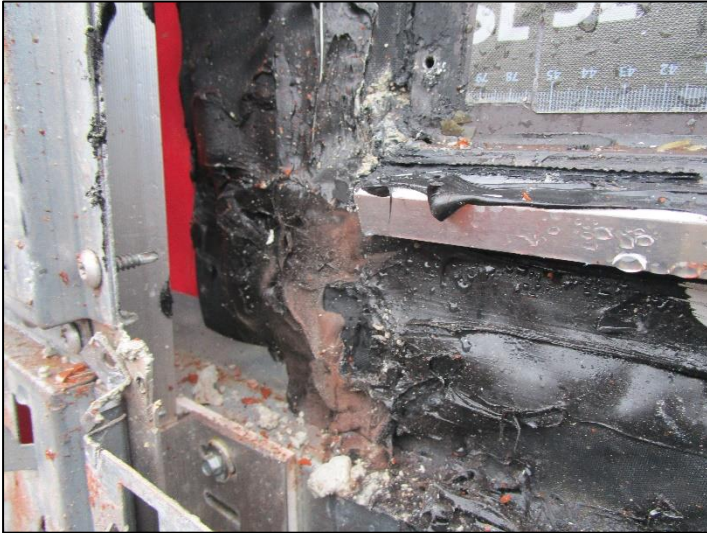
Photograph No. 33

External EPDM detail on  
window pod interface

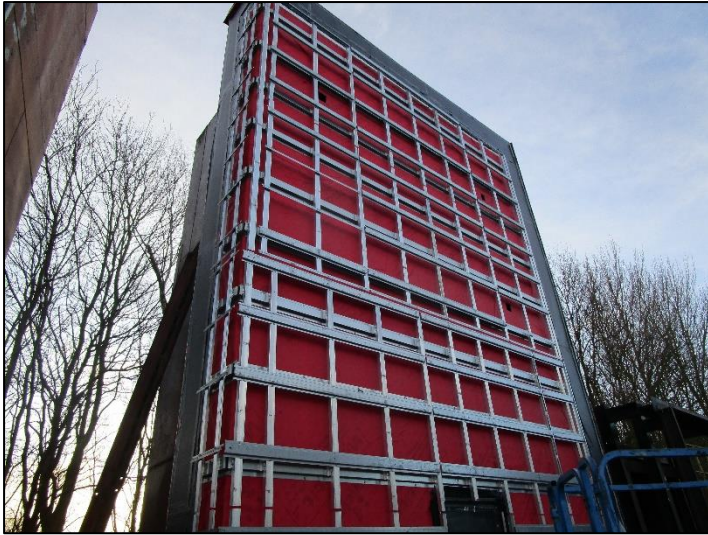
Photograph No. 36

Support rail and top hat layout

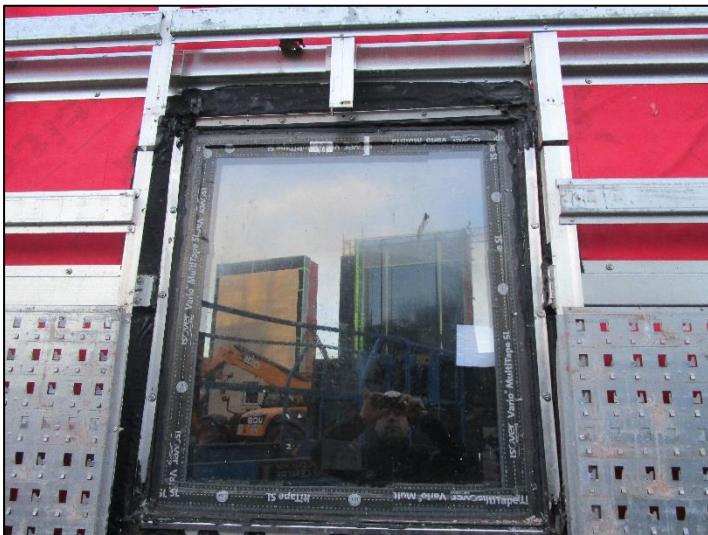
Photograph No. 37

Window pod with trays removed

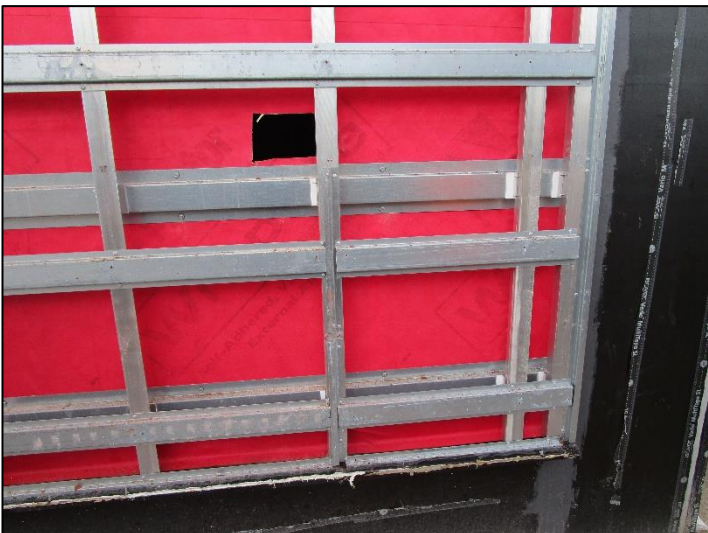
Photograph No. 38

Support rail and top hat layout

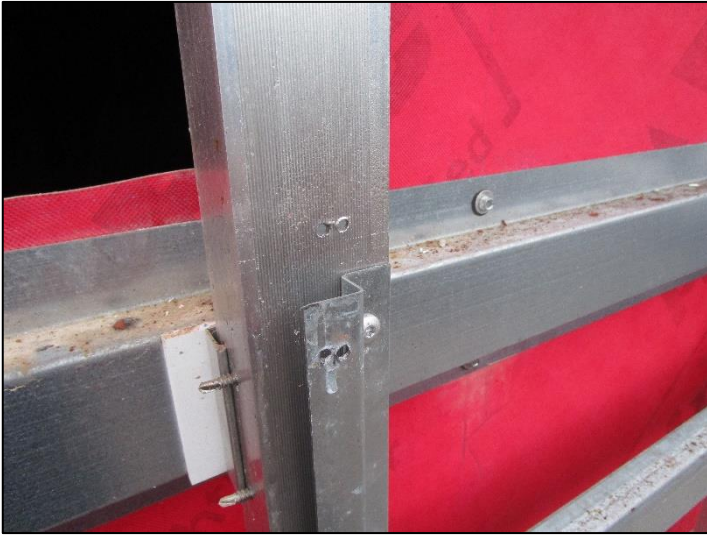
Photograph No. 39

Z flashing used

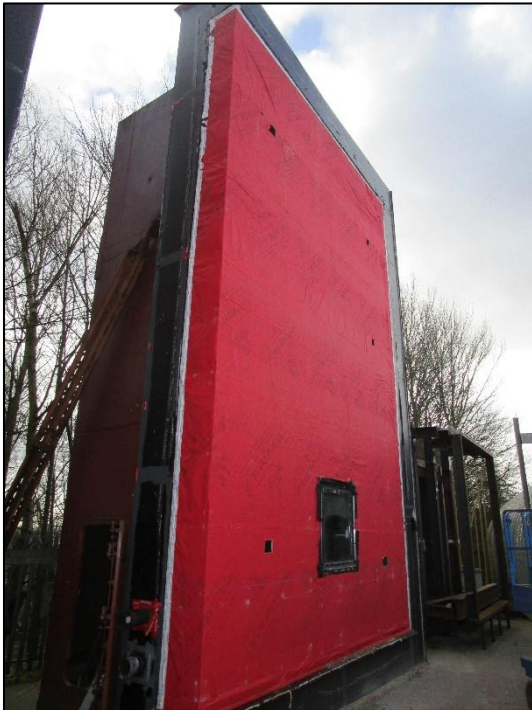
Photograph No. 43

Window pod detail

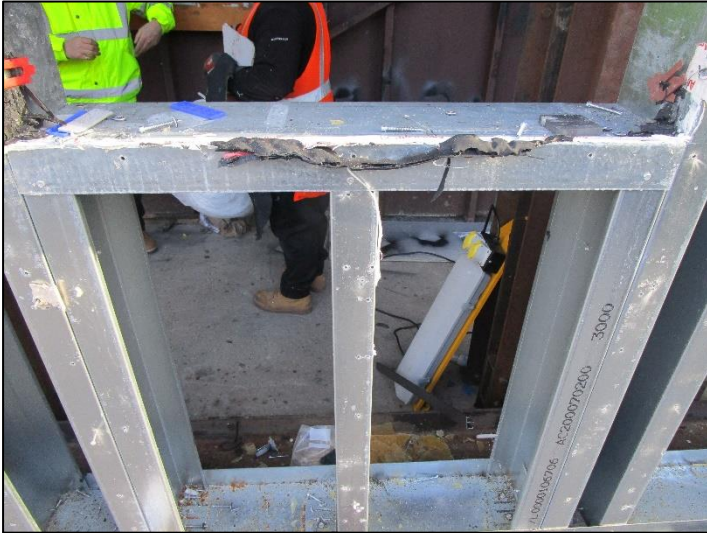
Photograph No. 49

Packers used on window pod interface to Metsec

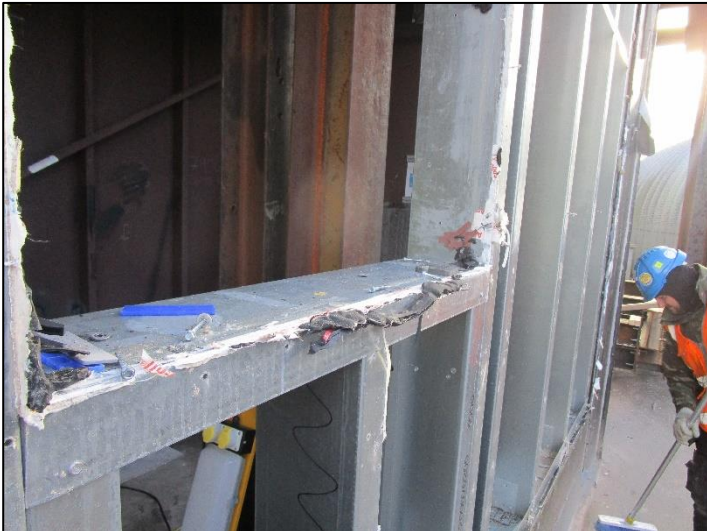
Photograph No. 50

Metsec section on underside  
of window pod

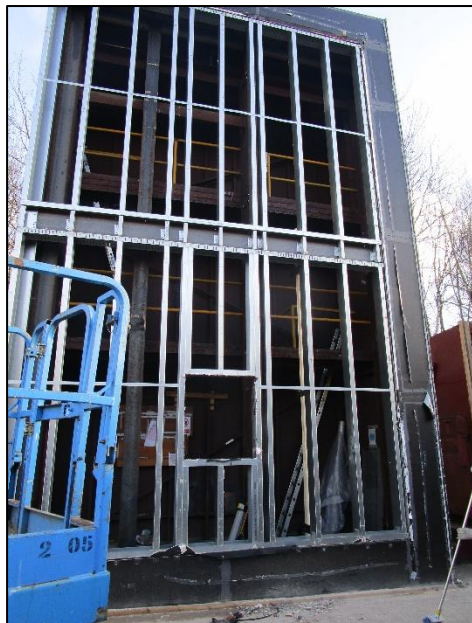
Photograph No. 51

Metsec section on underside  
of window pod
